# B. WETLAND DELINEATION REPORT

**Re:** Vernal Habitat Assessment Survey Results  
Trenton-Mercer Airport  
Portion of Block 373, Lot 6  
Ewing Township, Mercer County, New Jersey  
ASGECI Project #3200

Wetland Delineation Report

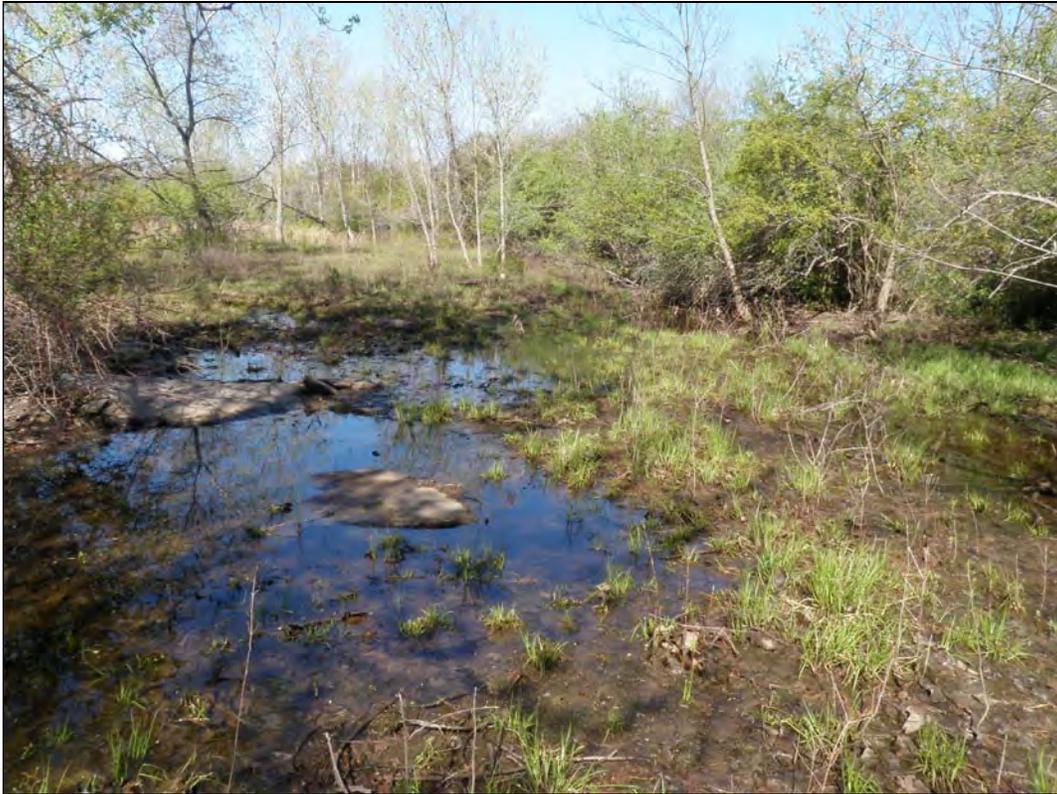
**Photo A** – View, facing northwest, of the area mapped as potential vernal habitat on April 29, 2015. The area contained an average of 1-3 inches of standing water.

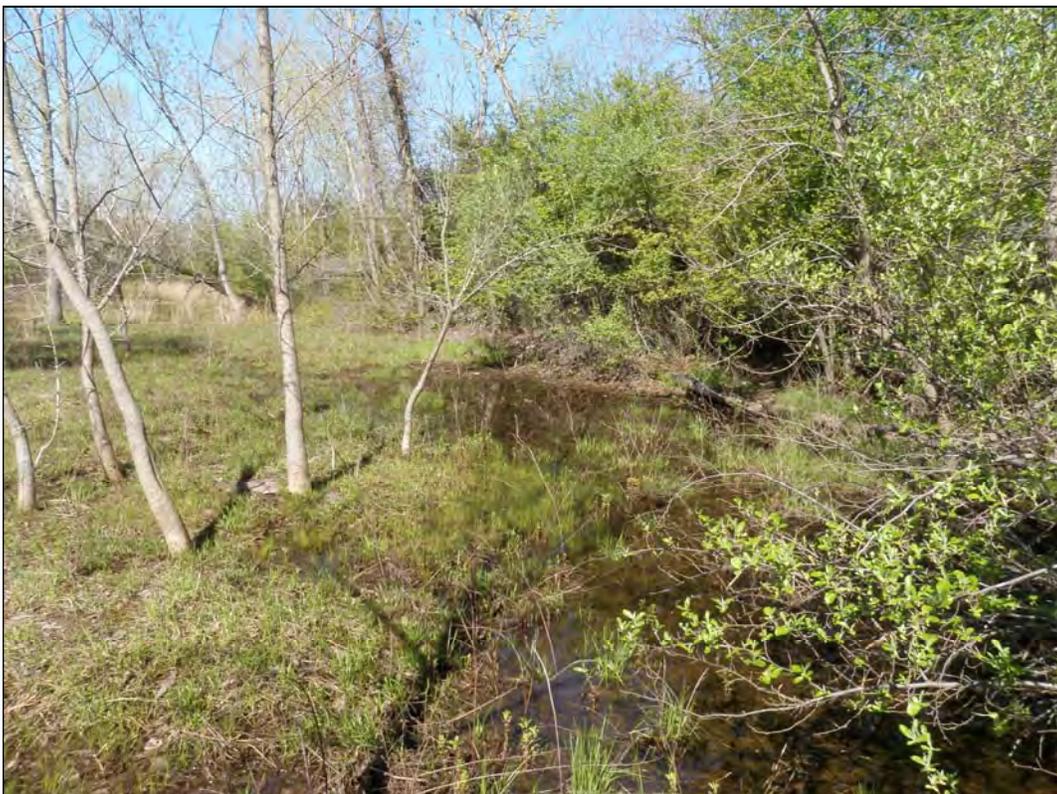
**Photo B** – View, facing north-northwest, of the area mapped as potential vernal habitat on April 29, 2015.

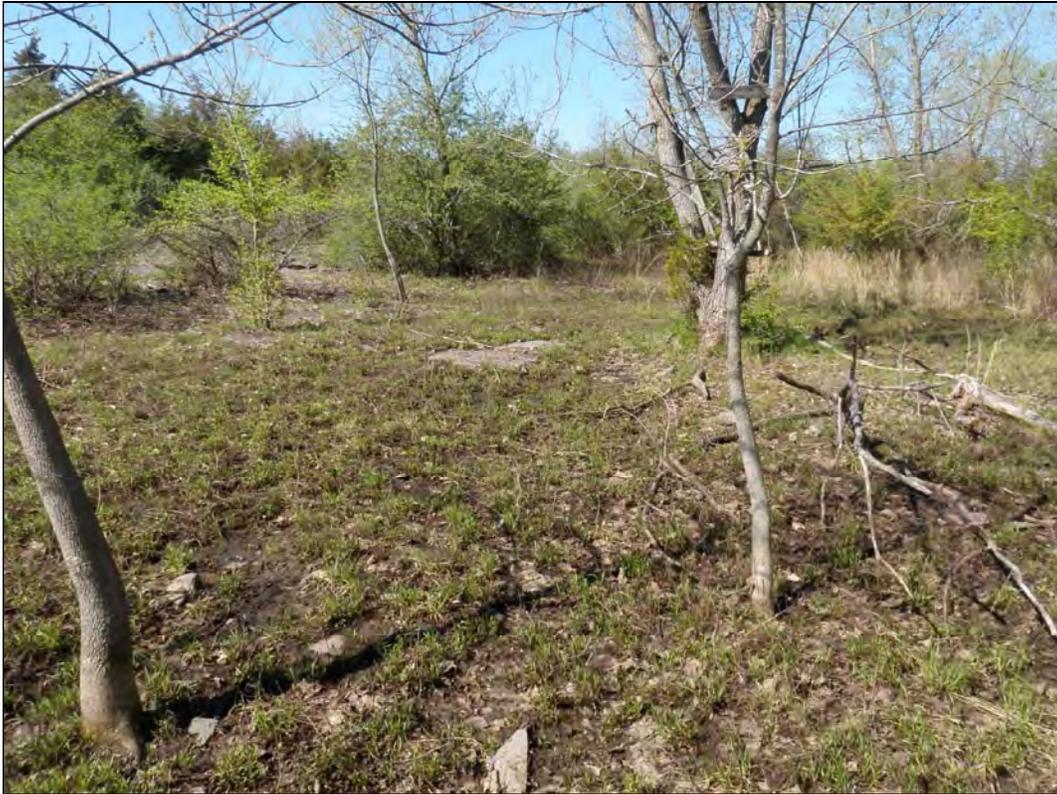
**Photo C** – View, facing southwest, of the northwestern portion of the mapped potential vernal pool area, which contained no standing water on April 29, 2015.

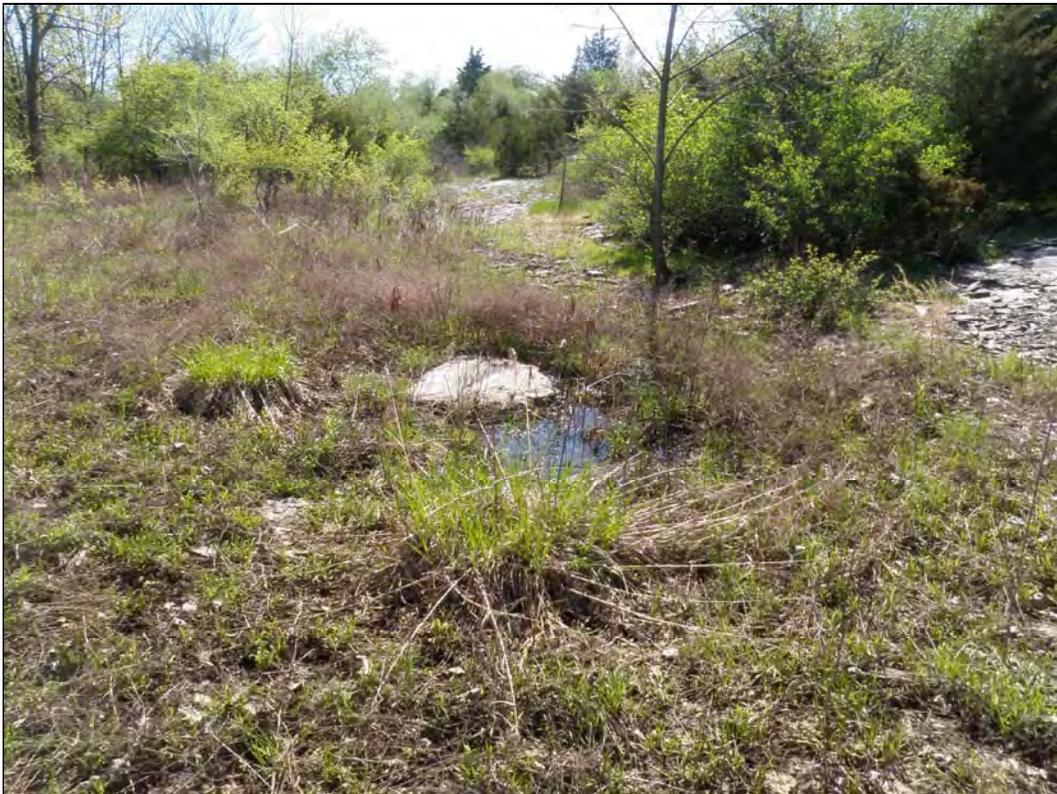
**Photo D** – View, facing southwest, showing an isolated pocket of standing water in the western portion of the mapped potential vernal pool on April 29, 2015. The exposed rock shelf is especially visible in the upper right portion of the photograph..

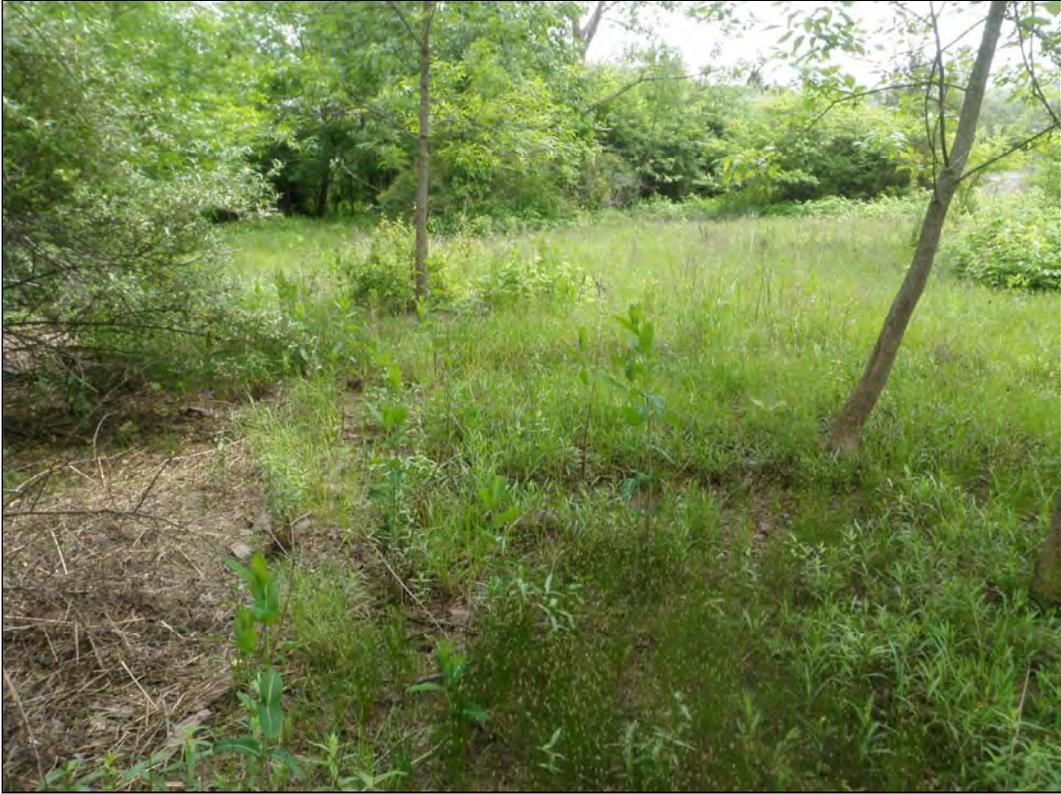
**Photo E** – View, facing south, of the area mapped as potential vernal pool on May 19, 2015. No standing water was present and vegetation cover increased since the previous site visit.

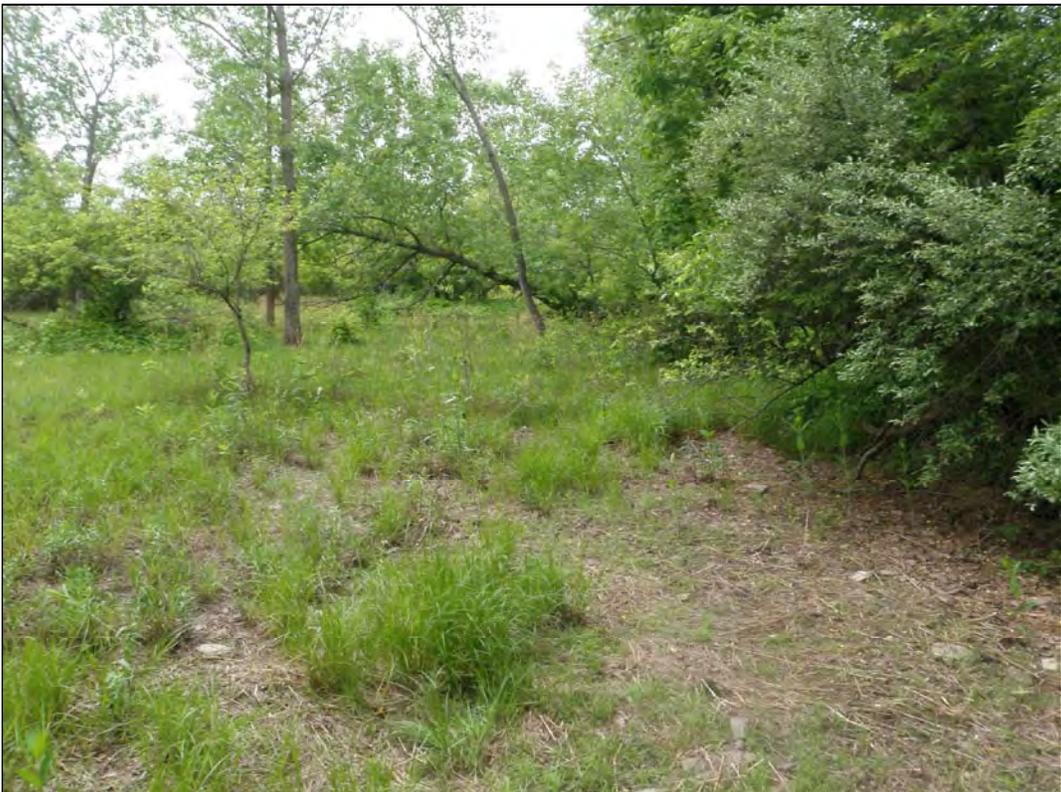
**Photo F** – View, facing north, of the area mapped as potential vernal pool on May 19, 2015.

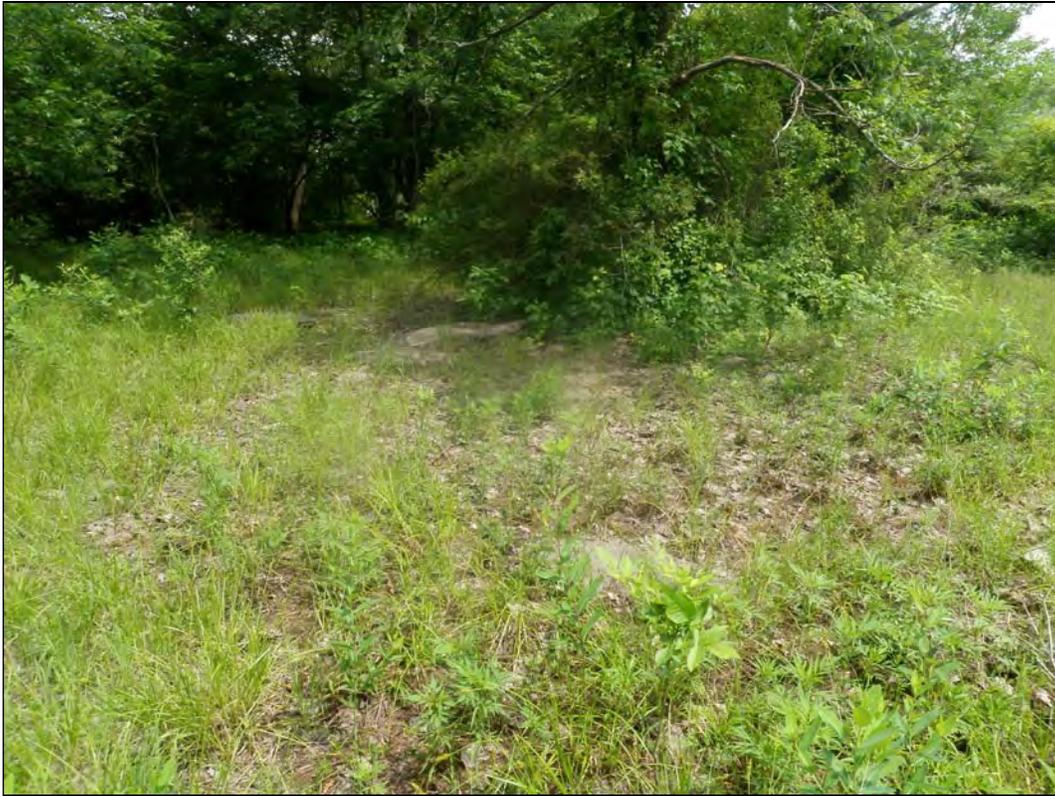
**Photo G** – View of the area mapped as potential vernal habitat on June 17, 2015. No standing water was present.

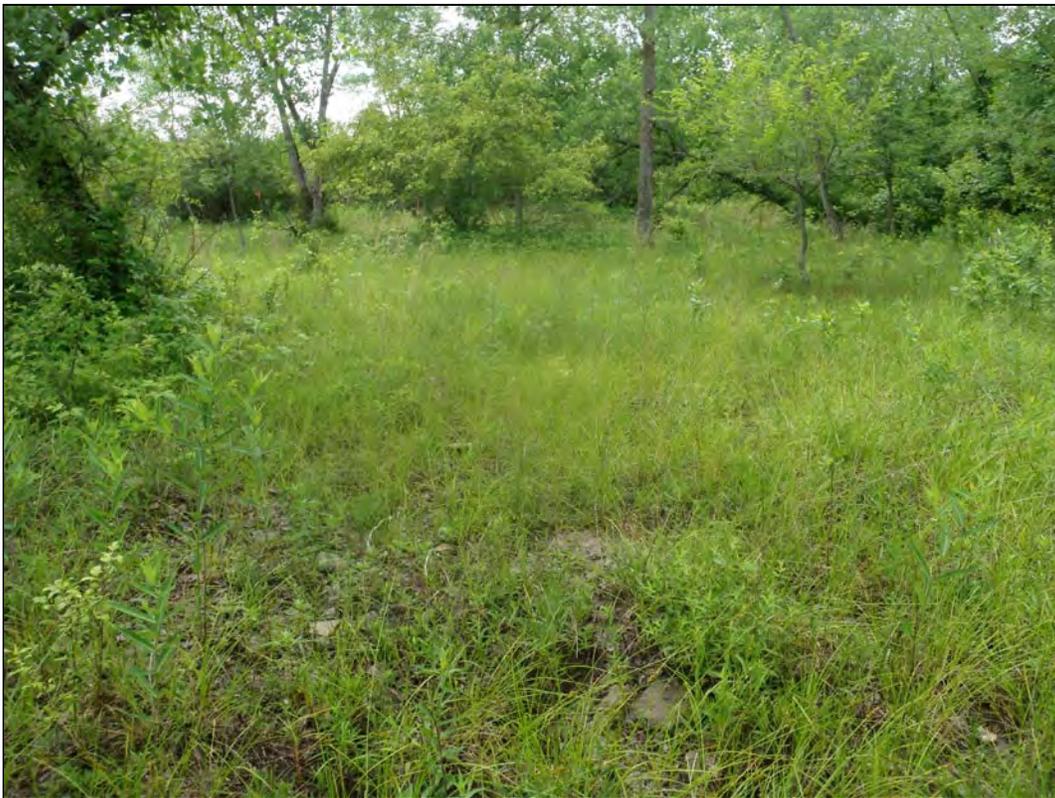
**Photo H** – View of the area mapped as potential vernal habitat on June 17, 2015.

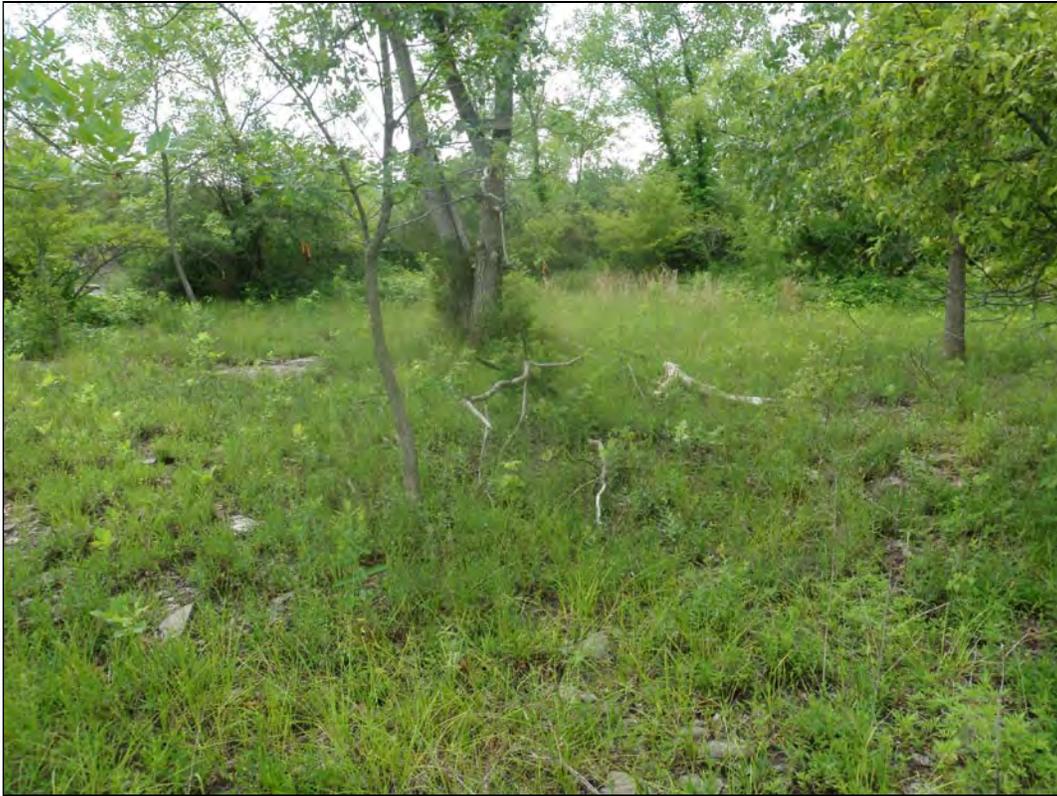
**Photo I** – View of the area mapped as potential vernal habitat on June 17, 2015.

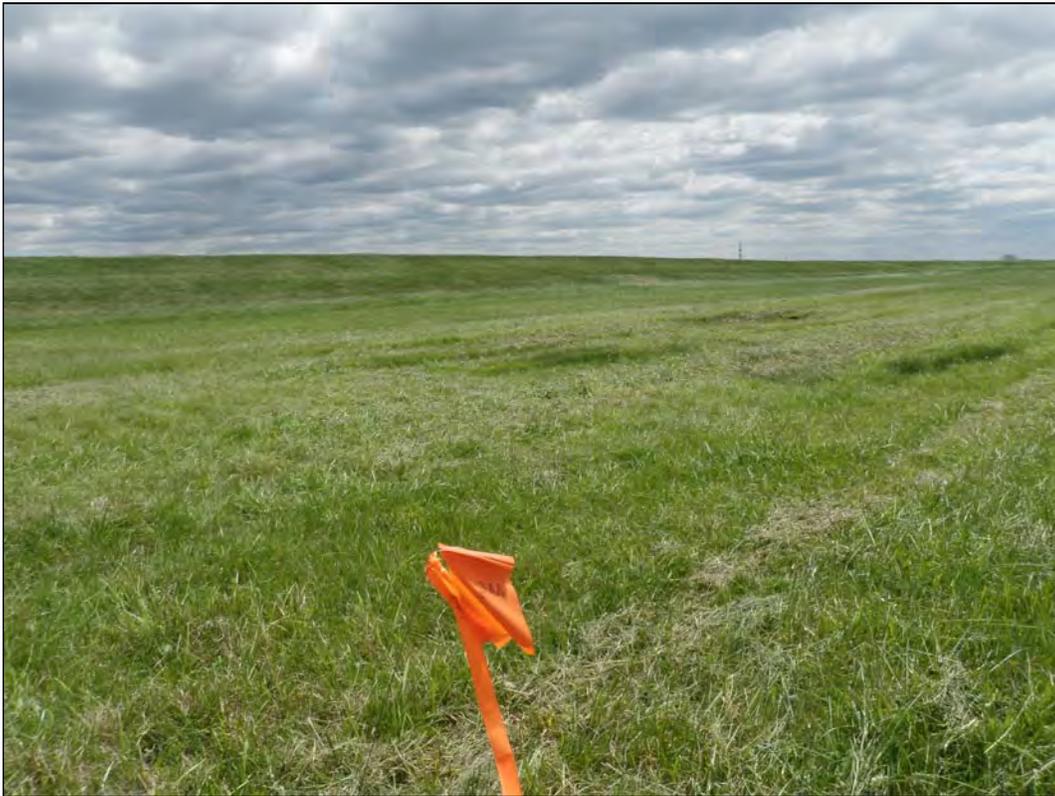
**Photo A** – View, facing southeast at Flag AA5, of a Palustrine emergent wetland basin located between Taxiway G and Runway 16-34.

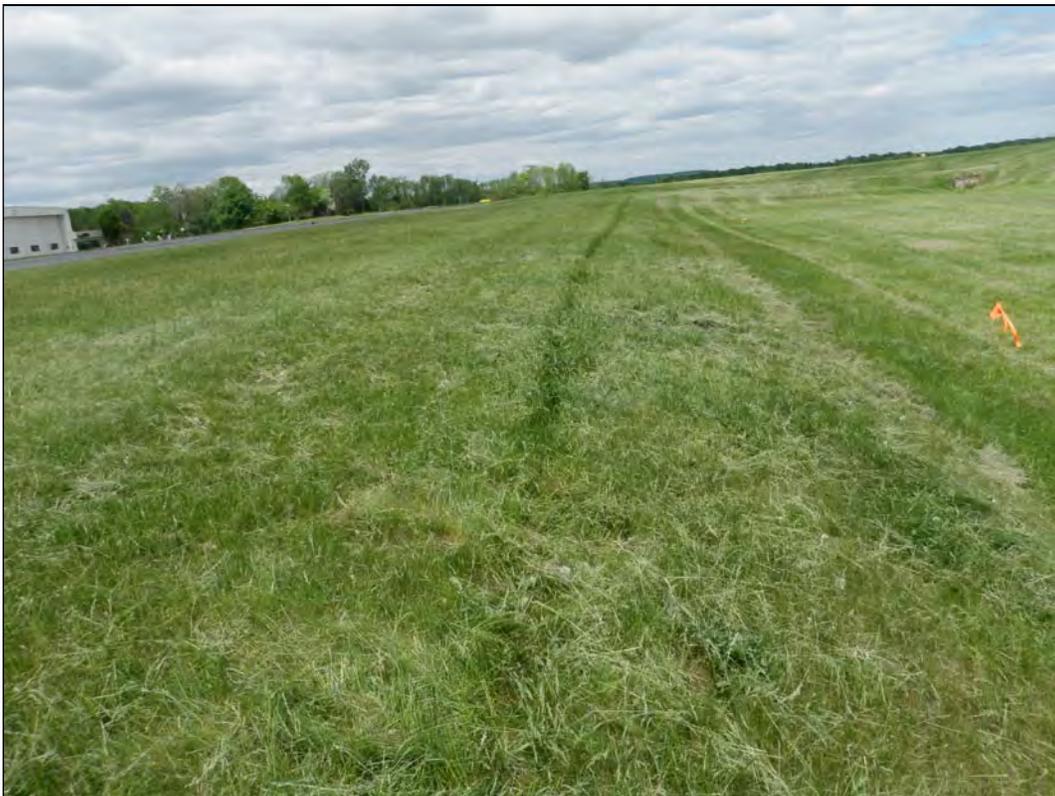
**Photo B** – Typical view, facing north-northwest near Flag AA5, of a maintained upland field located along Taxiway G.

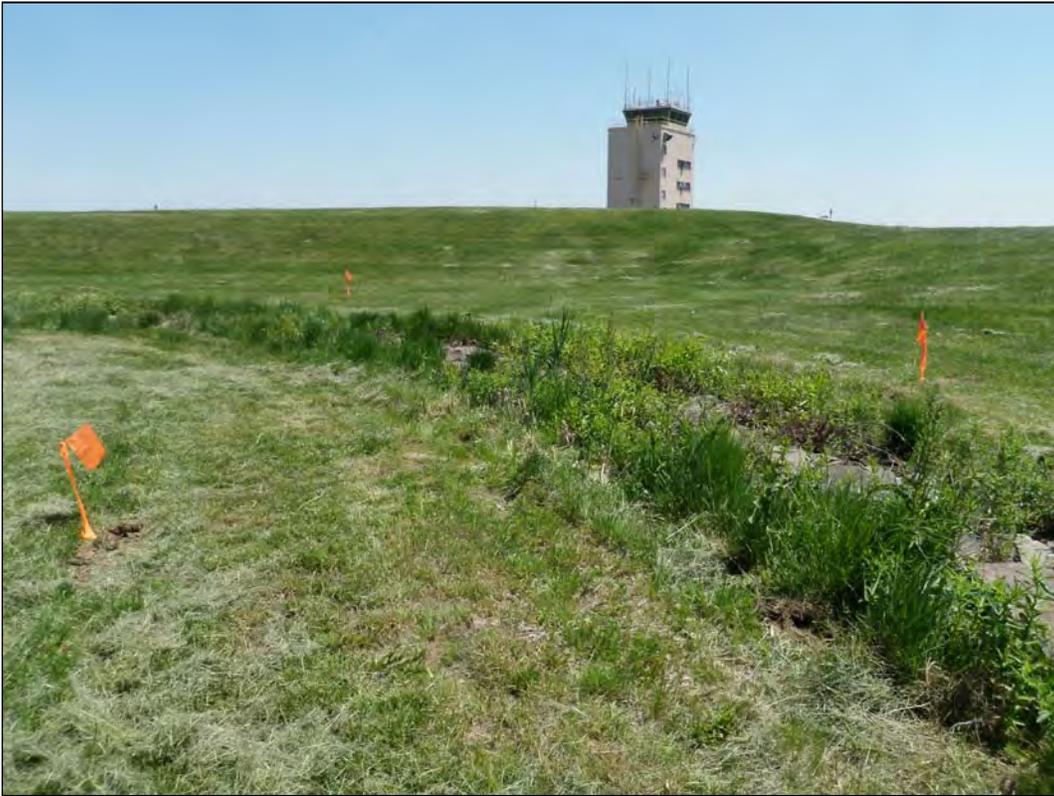
**Photo C** – View, facing east toward Flag CC6, of a manmade Palustrine emergent wetland swale located west of Taxiway A.

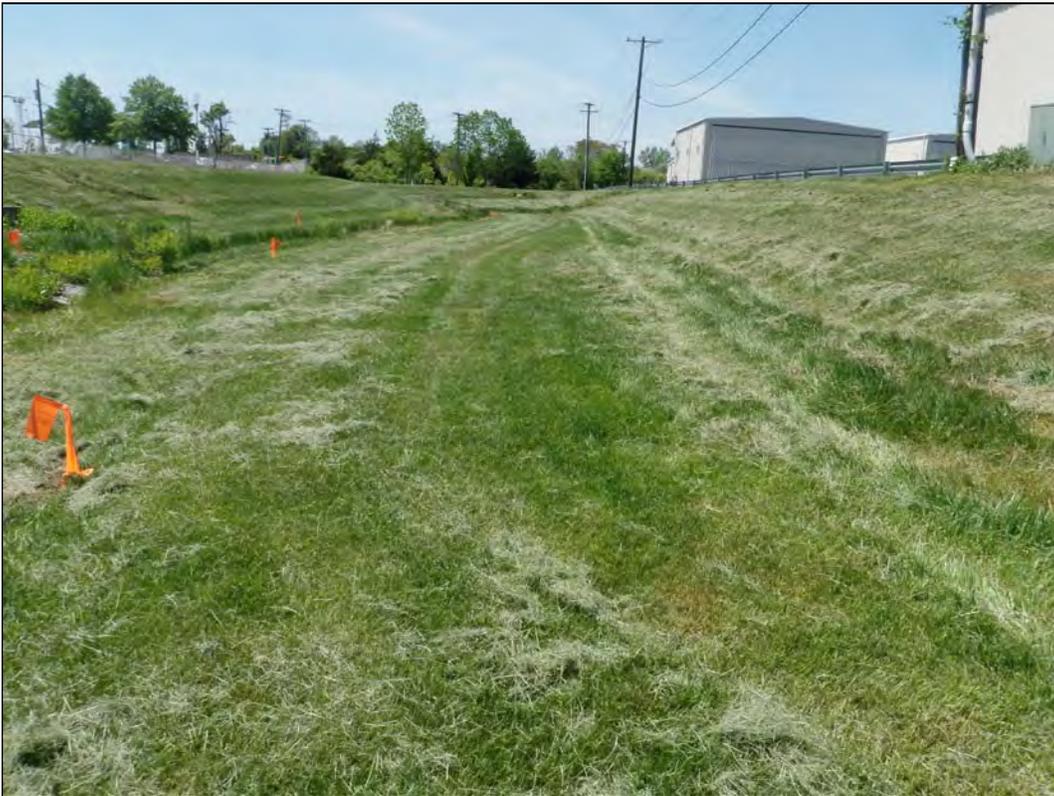
**Photo D** – View, facing west near Flag CC6, of maintained upland lawn in the vicinity of Taxiway A.

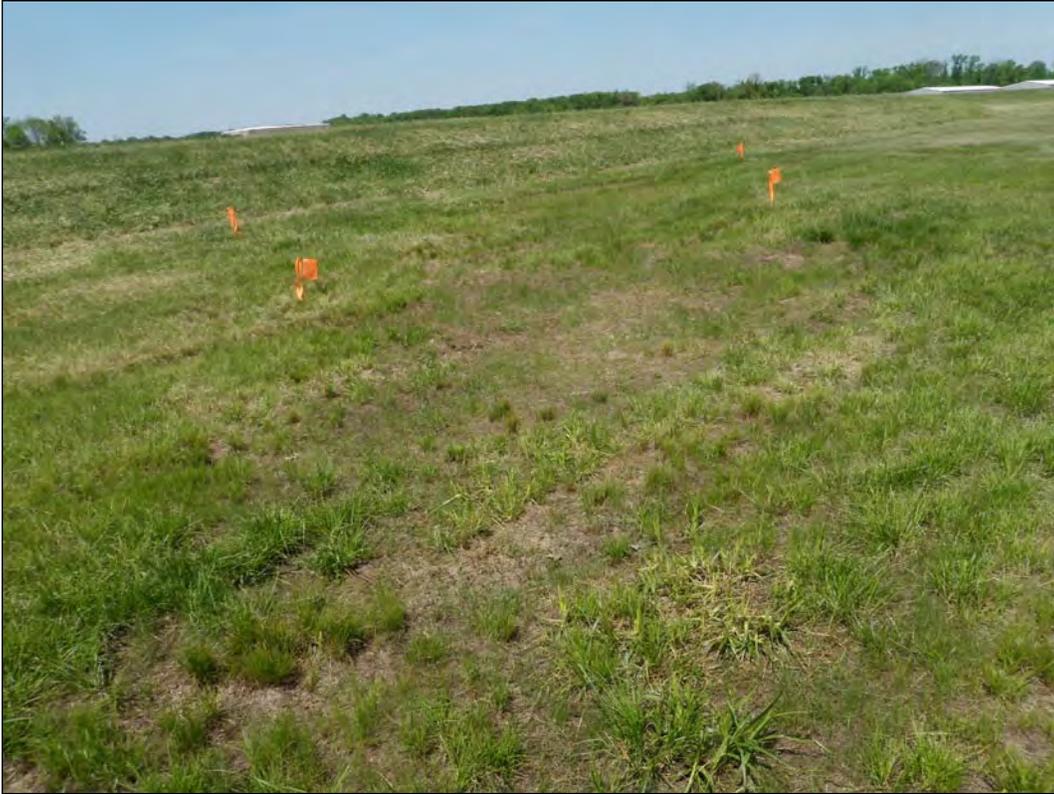
**Photo E** – View, facing northeast toward Flag EE1, of an isolated Palustrine emergent wetland located southwest of Taxiway G.

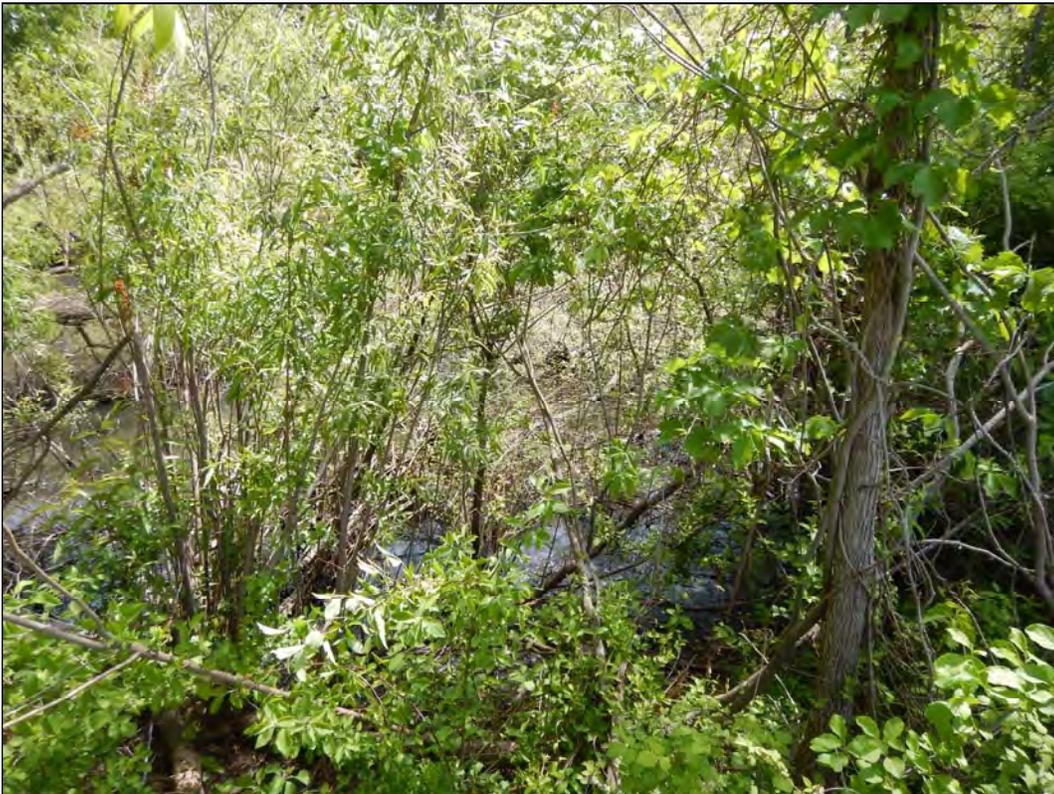
**Photo F** – View, facing northeast at Flag HH3, showing Palustrine forested wetland and ponded area located west-southwest of Scotch Road. Wetland contained black willow, red maple, American elm and silky dogwood.

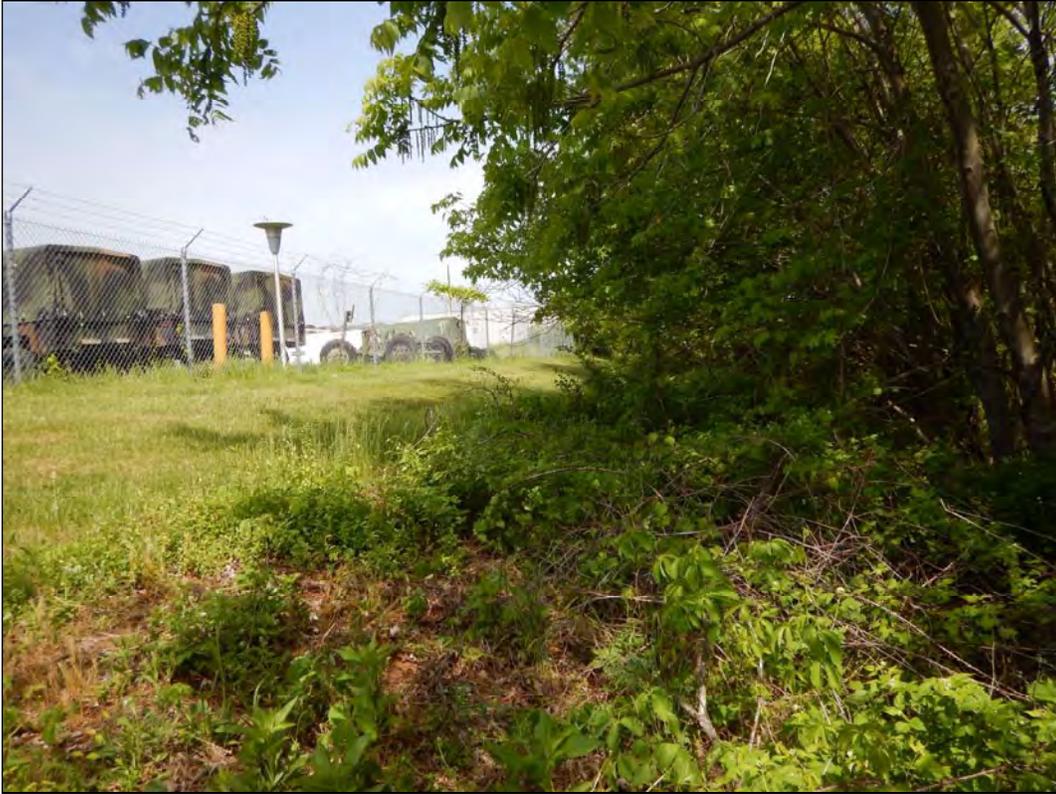
**Photo G** – View, facing northwest near Flag HH3, of mixed hardwood edge and maintained upland field.

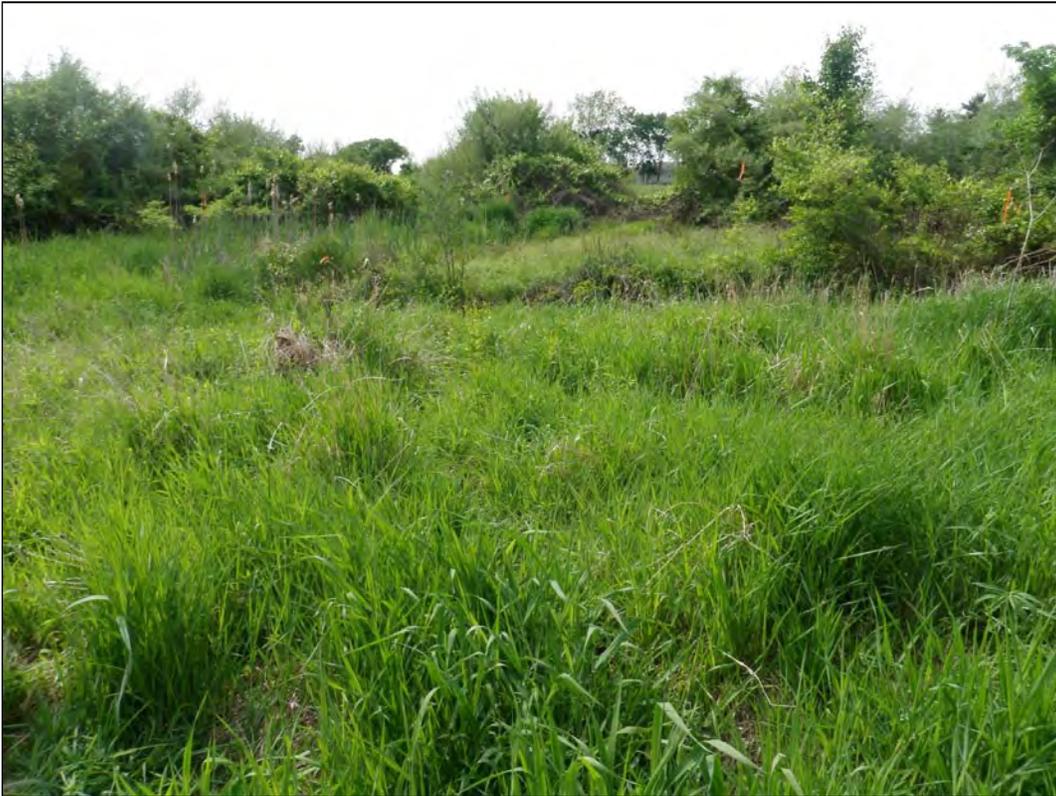
**Photo H** – View, facing west near Flag MM8, of a Palustrine emergent wetland complex dominated by reed canary grass and located southwest of Bear Tavern Road.

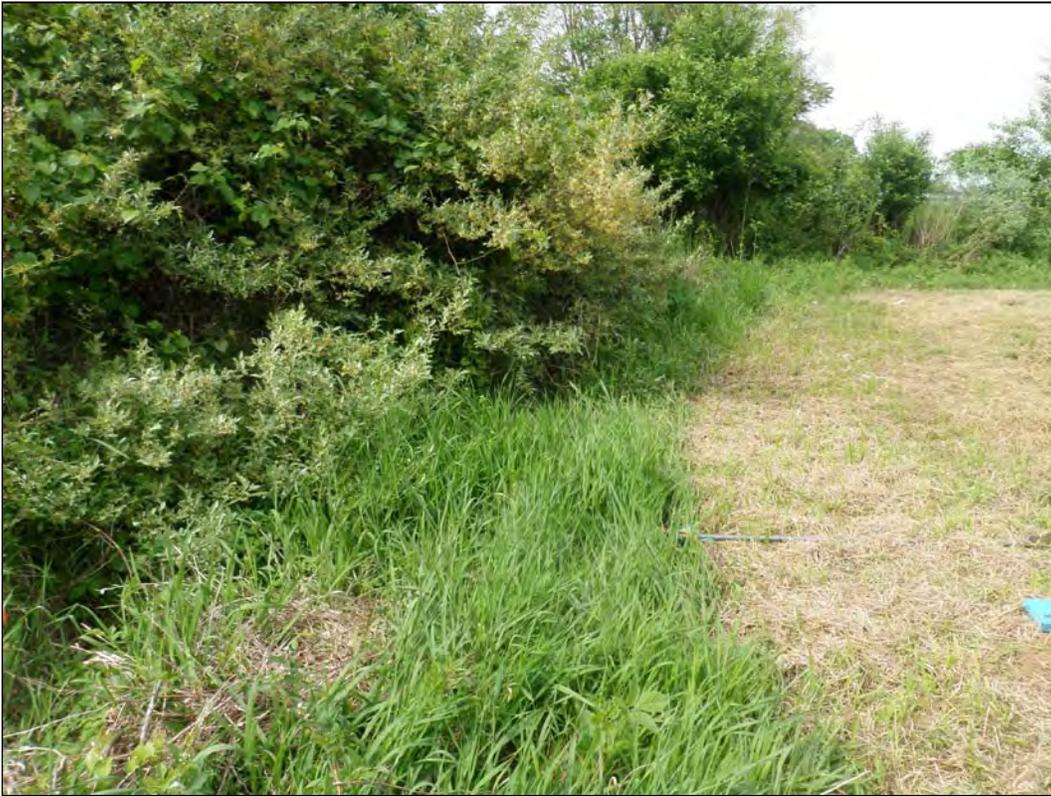
**Photo I** – View, facing north near Flag MM7 (facing MM6), of an early successional upland field located southwest of Bear Tavern Road.

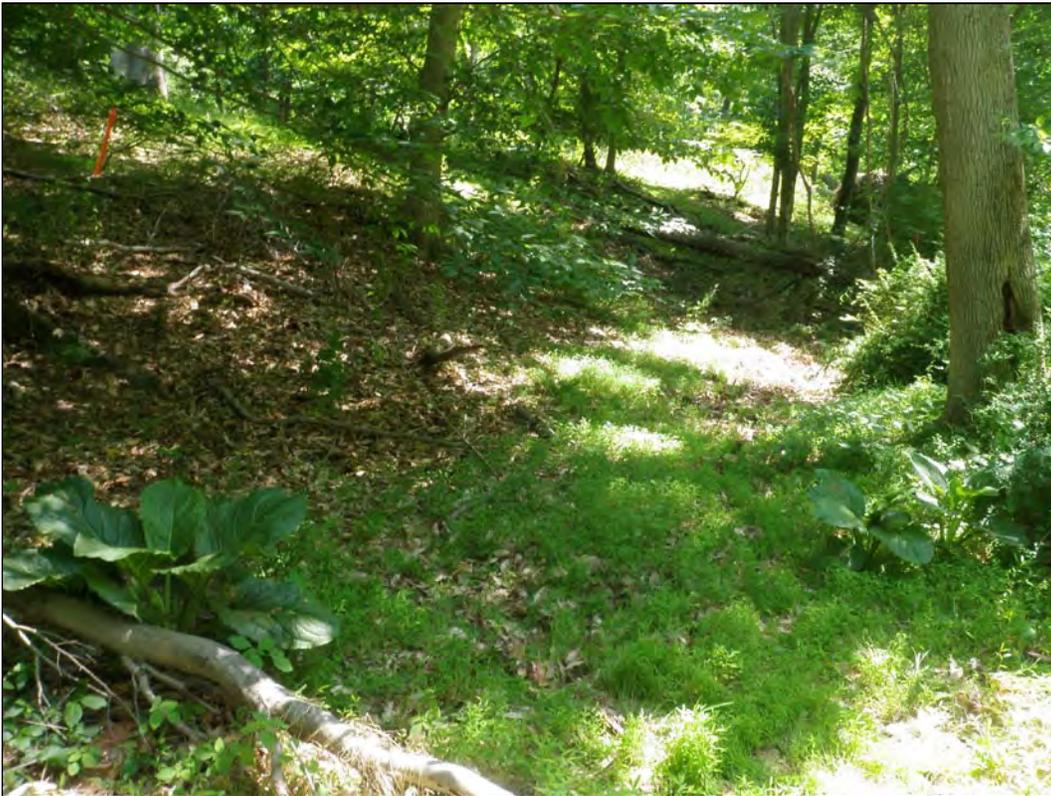
**Photo J** – View, facing south-southwest near Flag QQ23, of Palustrine forested wetland adjacent to an unnamed tributary to the Delaware River.

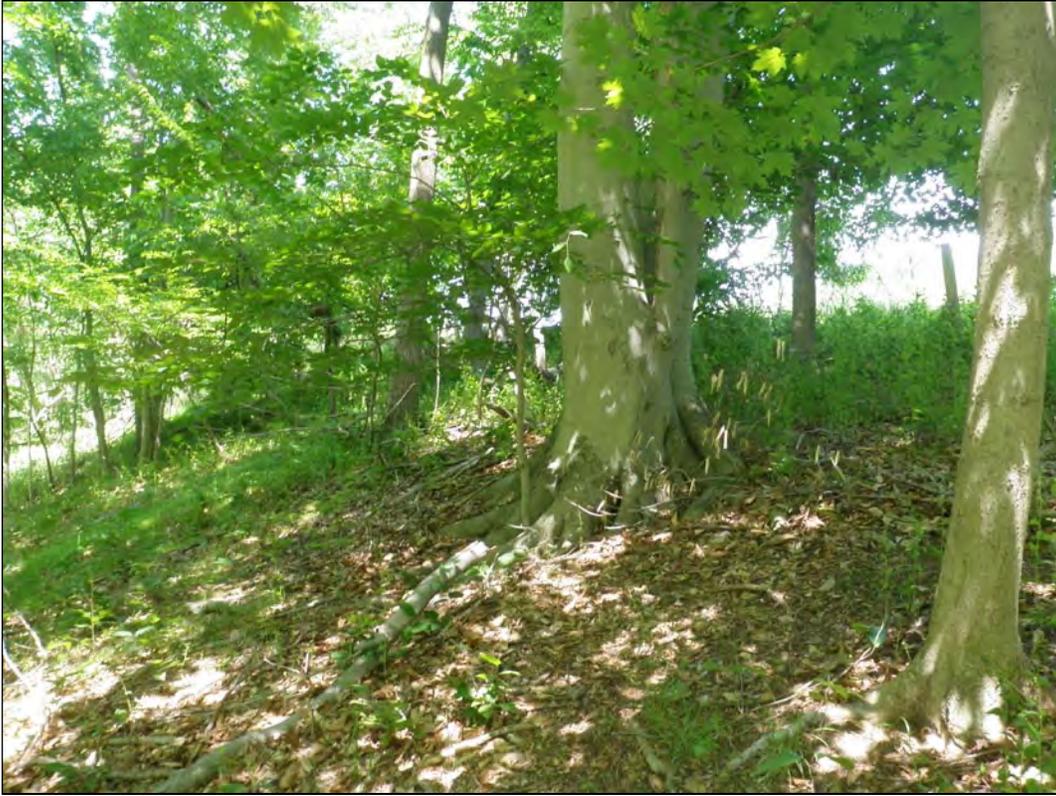
**Photo K** – View, facing northeast near Flag QQ22, of a secondary growth upland forest containing American beech, Northern red oak, sugar maple, garlic mustard, and Japanese stiltgrass.

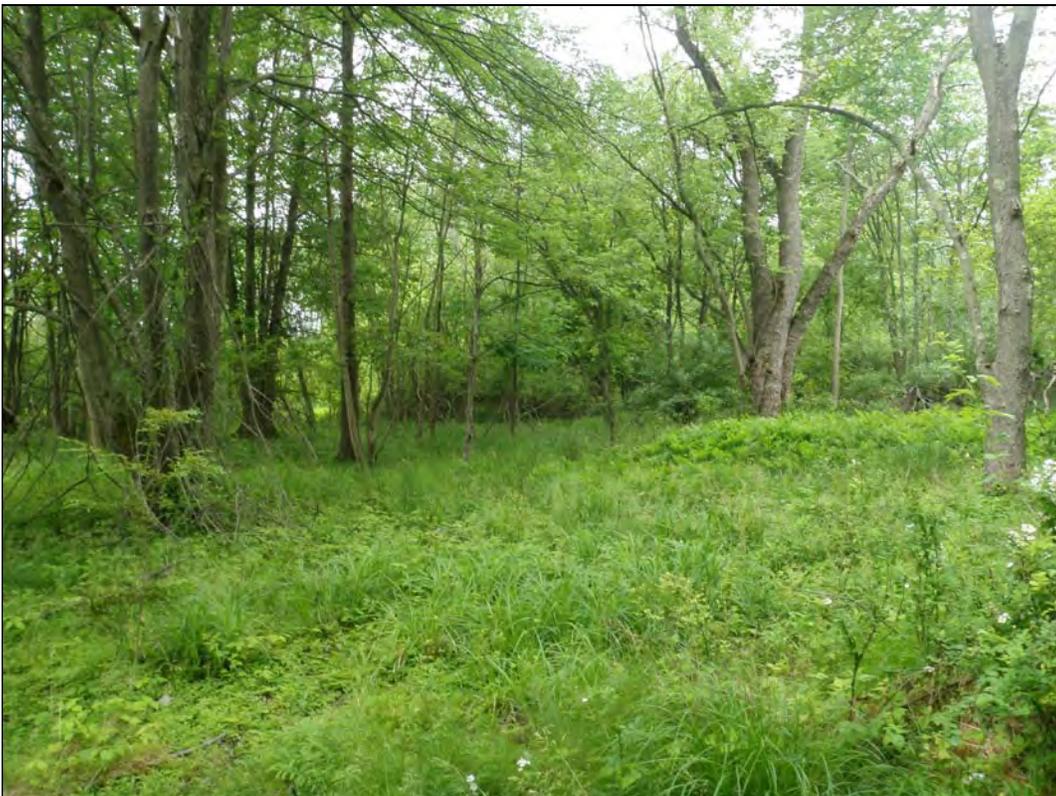
**Photo L** – View, facing southwest at Flag TT100, of a Palustrine forested wetland complex located east-southeast of Sam Weinroth Road. Wetland contained red maple, silver maple, Northern spicebush, sedges, *Glyceria*, moneywort, and sensitive fern.

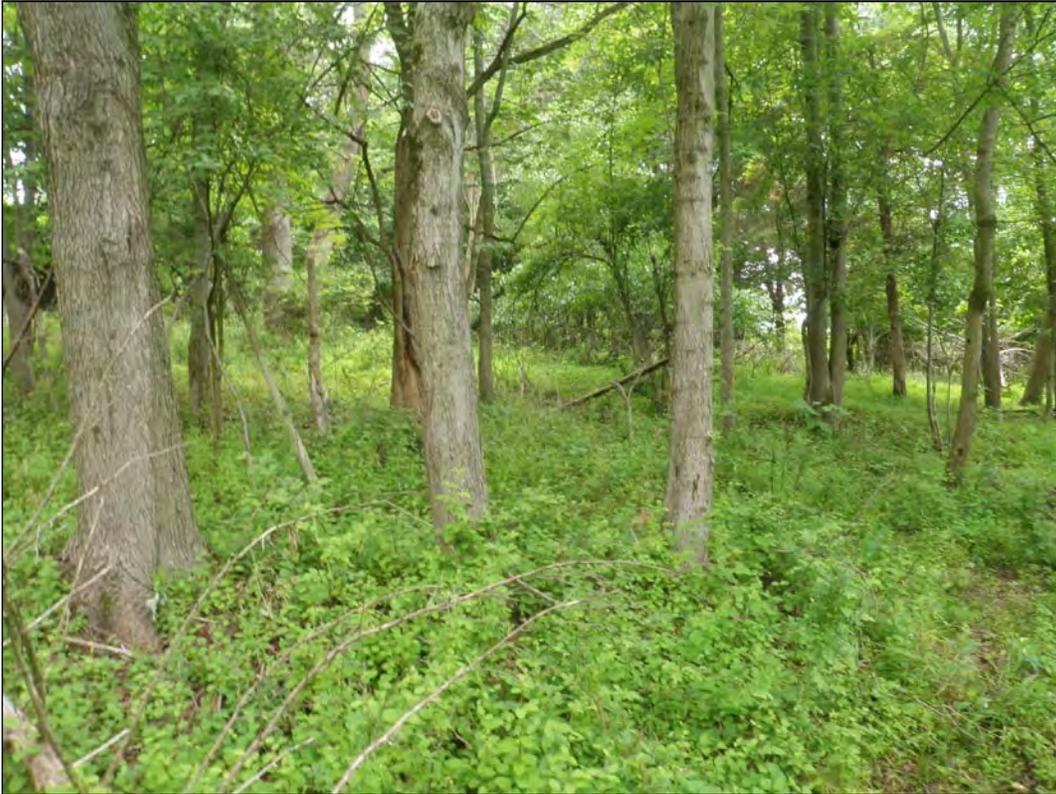
**Photo M** – View, facing northeast near Flag TT100, of a secondary growth upland forest located east-southeast of Sam Weinroth Road.

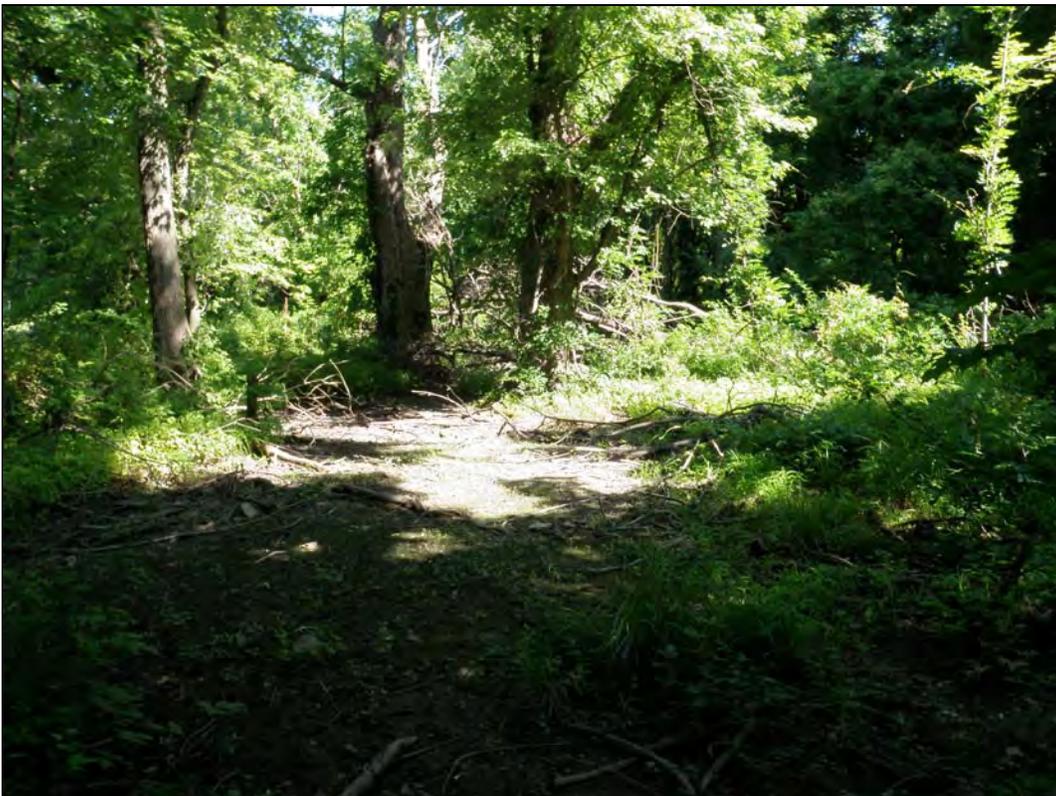
**Photo N** – View, facing northwest from Flag XX15, of a Palustrine forested wetland dominated by red maple, spotted jewelweed, *Glyceria*, and sedges. Wetland is located west of the Ewing Township Library along Scotch Road.

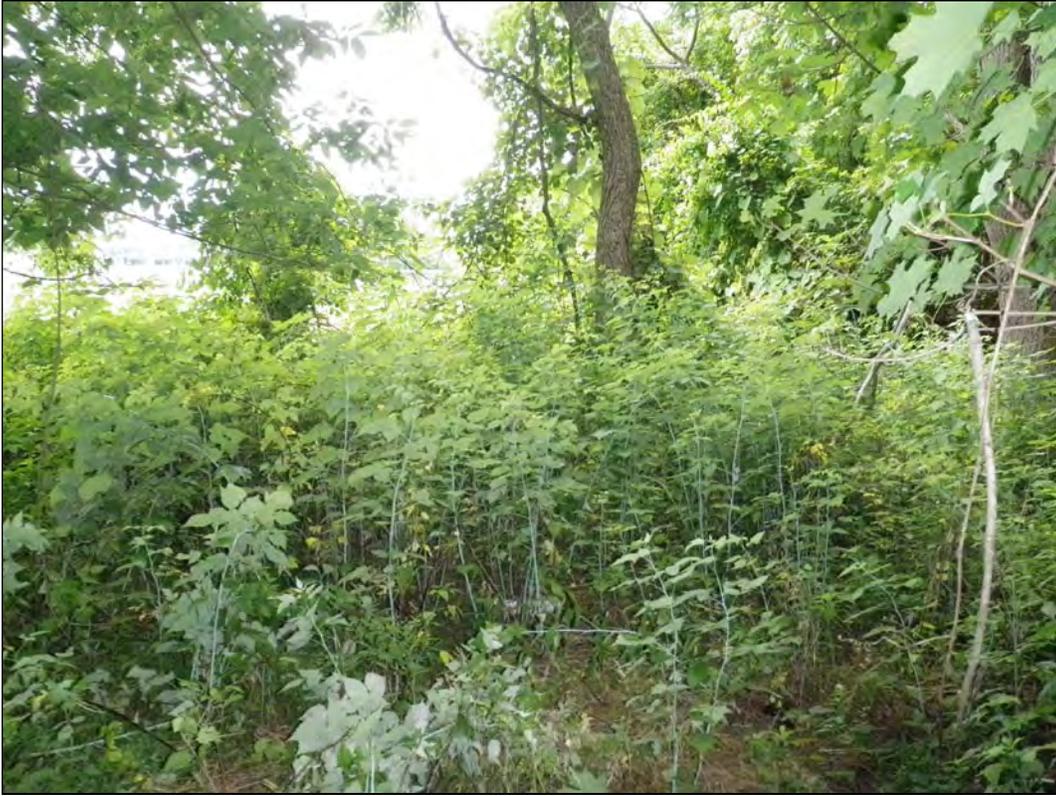
**Photo O** – View, facing southwest from XX15, of a secondary growth upland forest containing sugarberry, black cherry, black walnut, black raspberry, Japanese stiltgrass.

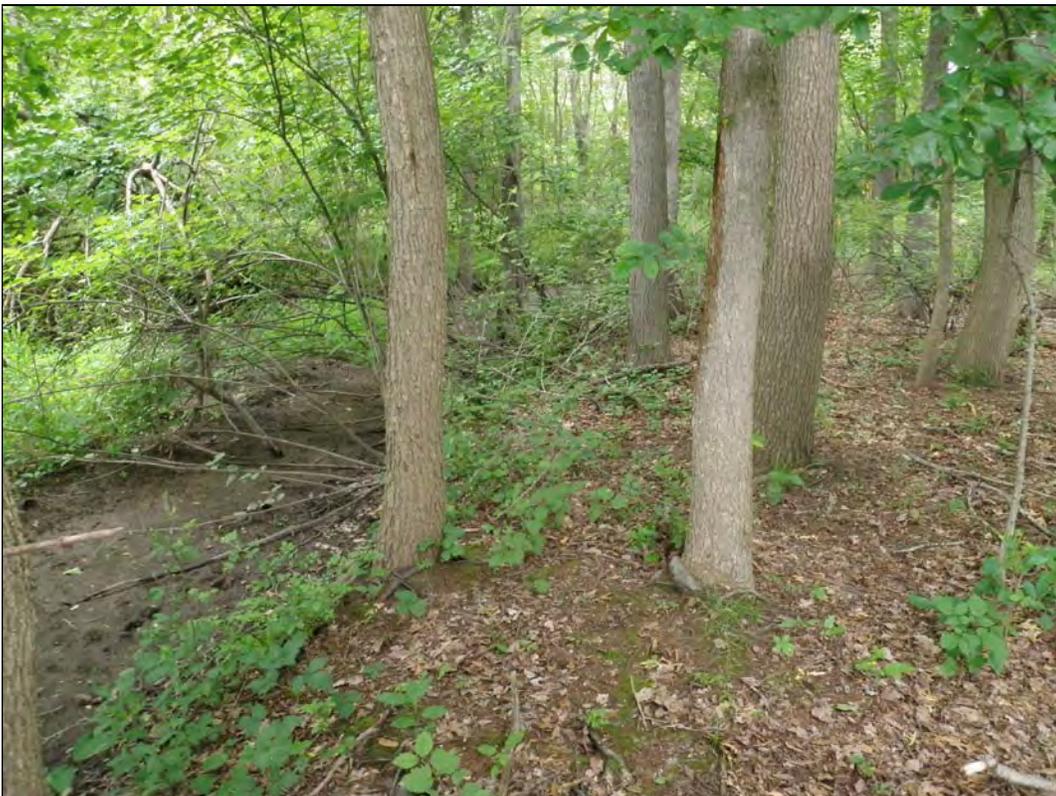
**Photo P** – View, facing west near Flag YY17, of a Palustrine forested wetland containing red maple, black gum, arrowwood, poison ivy, and Virginia creeper.

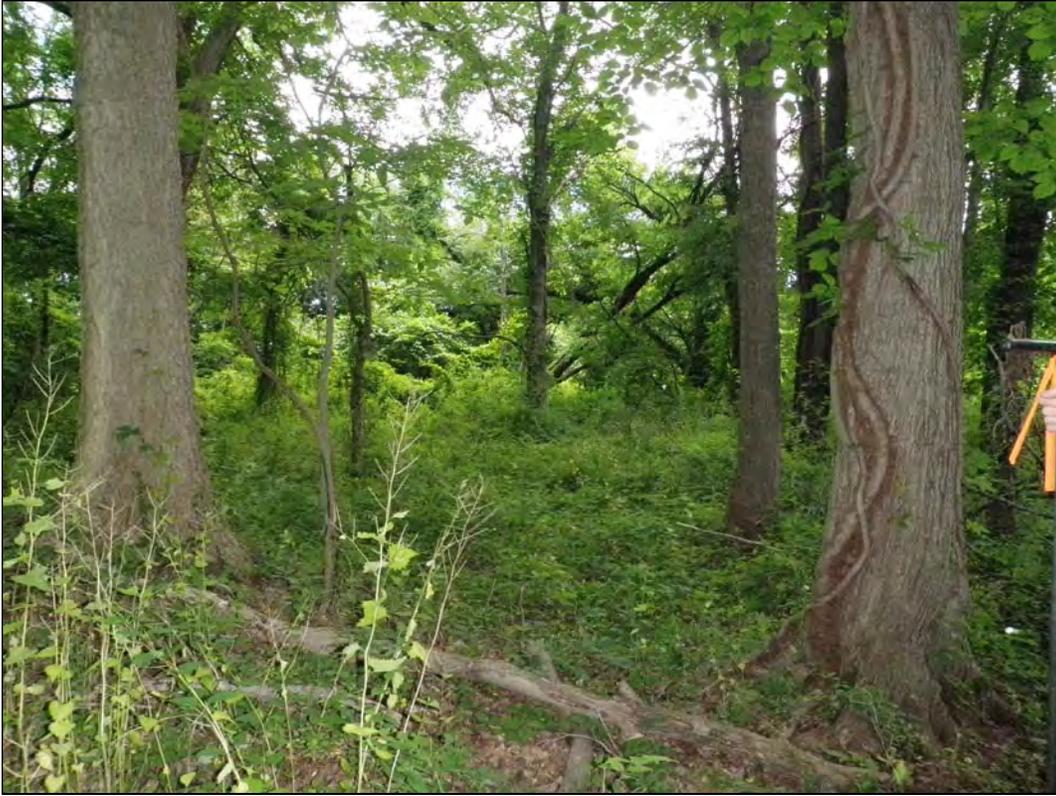
**Photo Q** – View, facing east-southeast near Flag YY17, of secondary growth upland forest containing black cherry, red maple, multiflora rose, poison ivy, Japanese honeysuckle, garlic mustard, and Virginia creeper.
