# B. WETLAND DELINEATION REPORT

**Re:** Vernal Habitat Assessment Survey Results  
Trenton-Mercer Airport  
Portion of Block 373, Lot 6  
Ewing Township, Mercer County, New Jersey  
ASGECI Project #3200

Wetland Delineation Report

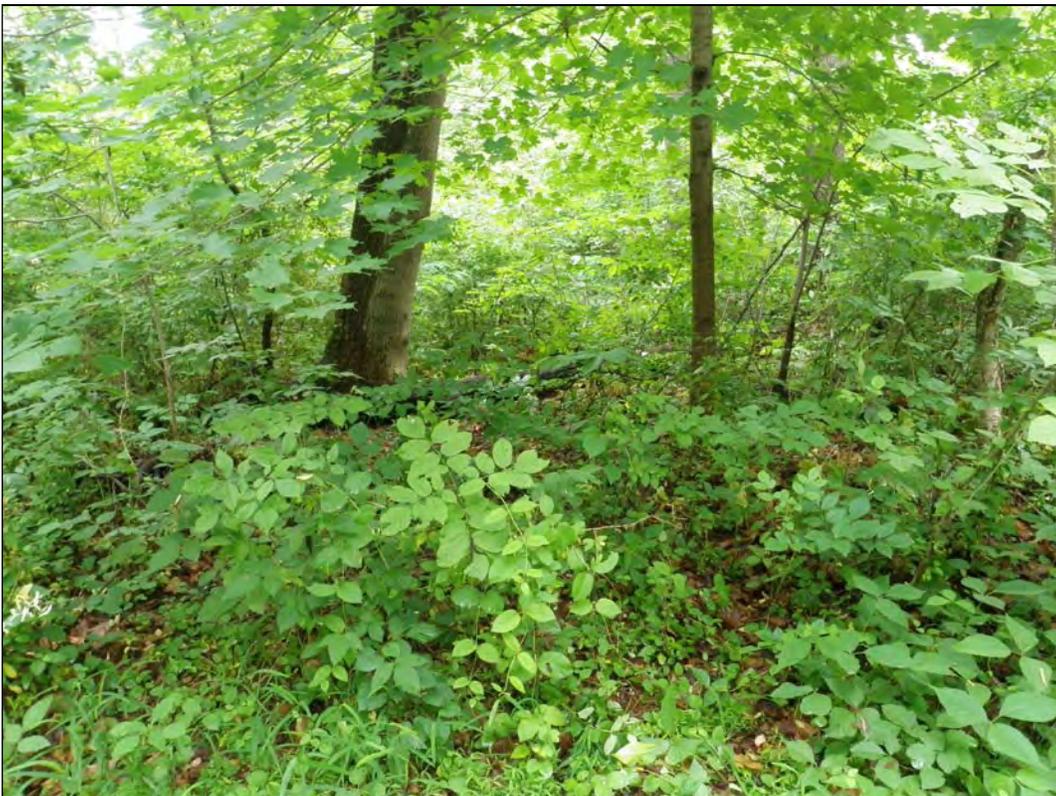
**Photo R** – View, facing east at Flag ZZ10, of a Palustrine forested wetland containing tulip poplar, red maple, green ash, Northern spice bush, Northern arrowwood, and Japanese stiltgrass. Wetland is situated north of Parkway Avenue and west of Jack Stephan Way.

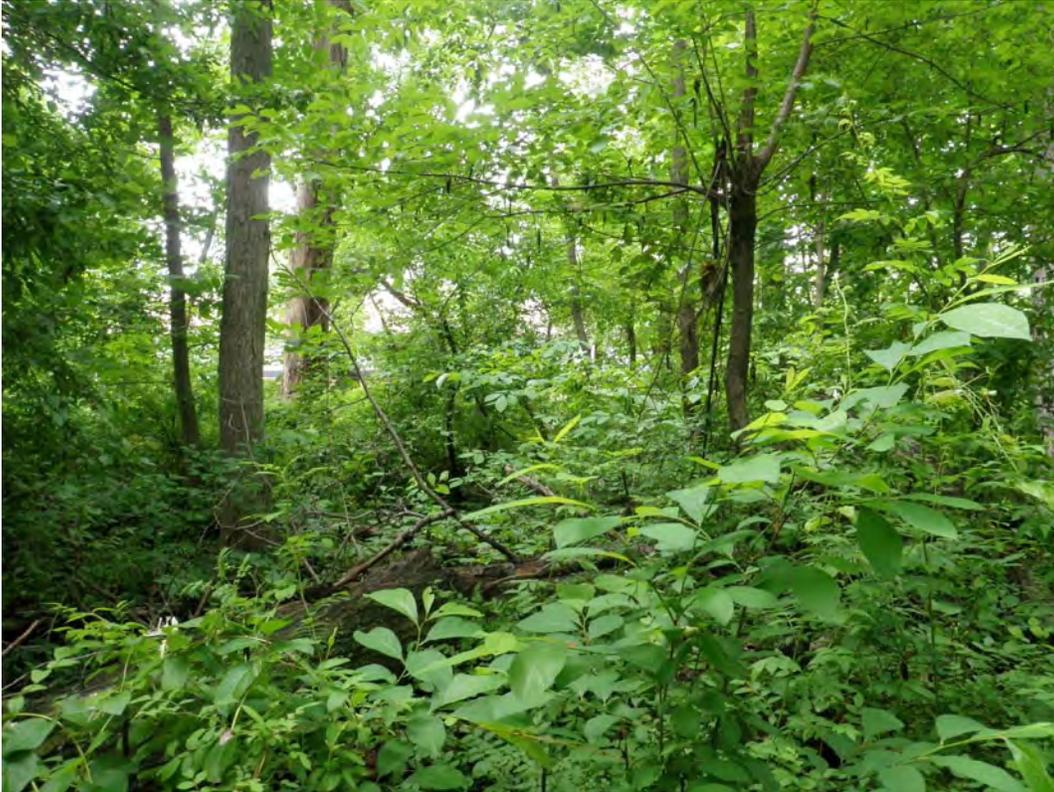
**Photo S** – View, facing west from Flag ZZ10, of secondary growth upland forest dominated by shagbark hickory, red maple, black cherry, Northern spicebush, Japanese honeysuckle, and may apple.

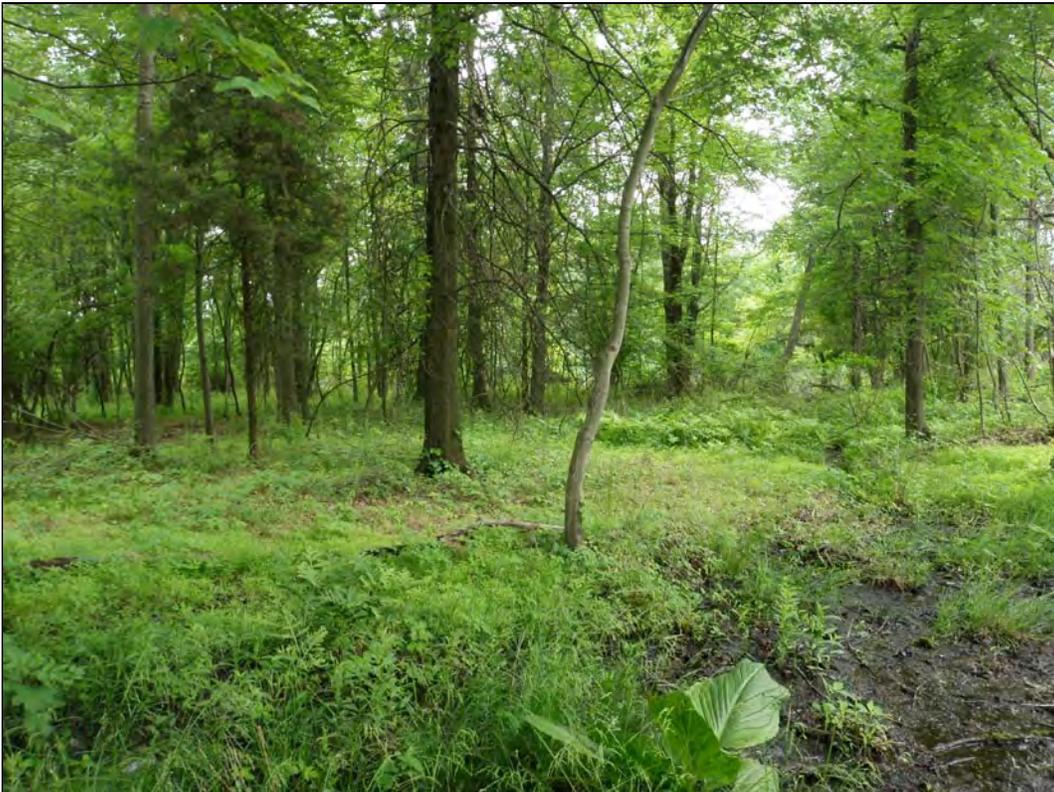
**Photo T** – View, facing south near Flag CA25, of a forested wetland dominated by pin oak, red maple, Northern spicebush, Japanese stiltgrass, jewelweed, and false nettle. Wetland is located west of Lower Ferry Road.

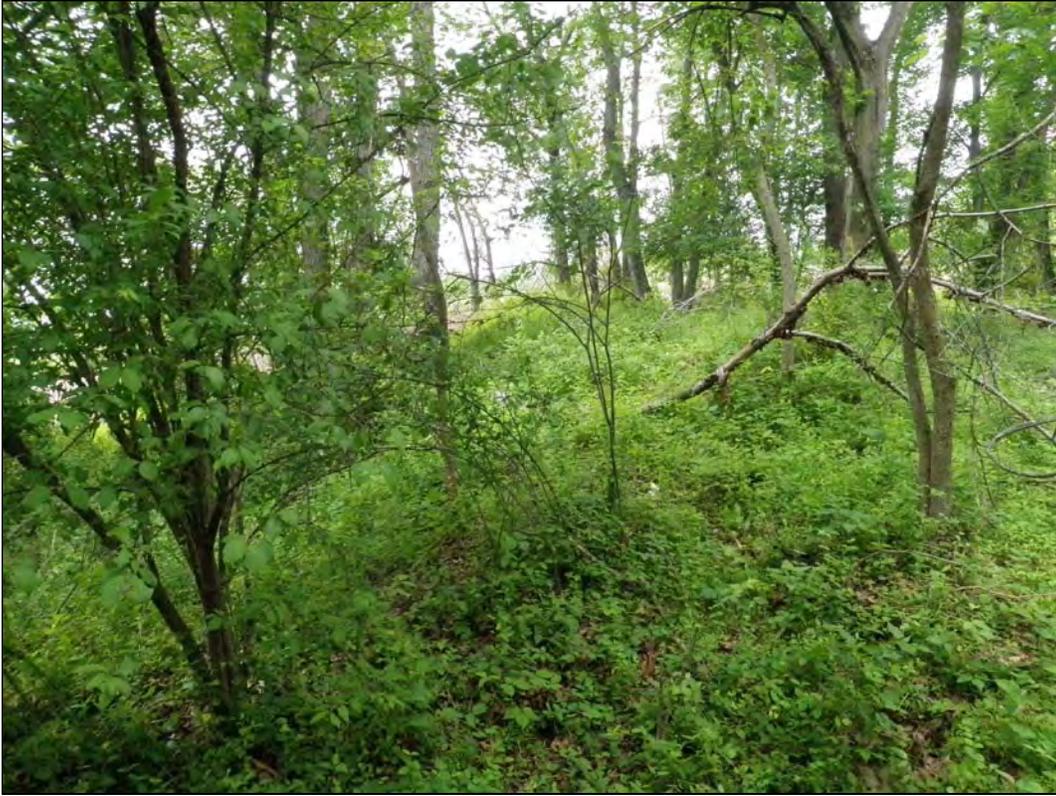
**Photo U** – View, facing north near Flag CA25, of a secondary growth upland forest containing black cherry, sassafras, blackhaw, Japanese stiltgrass, Japanese honeysuckle, white snakeroot, and poison ivy.

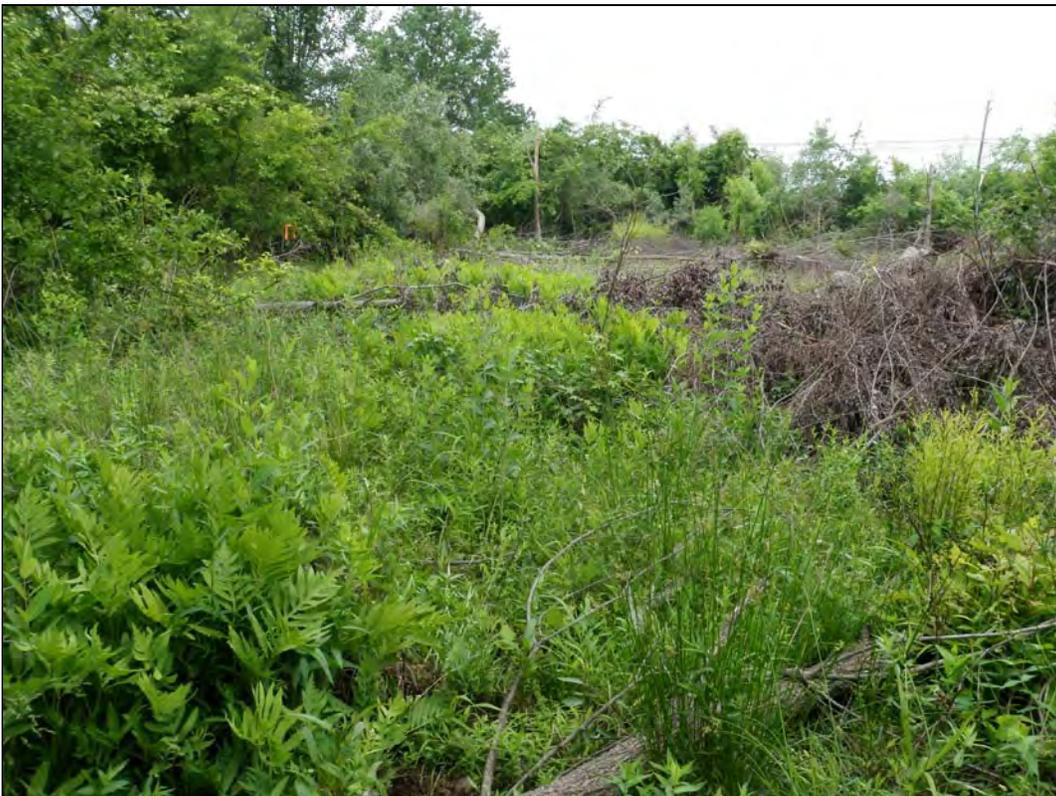
**Photo V** – View, facing east from Flag EA1, of an isolated emergent wetland located west of Lower Ferry Road. The wetland contained soft rush, sensitive fern, purple loosestrife, Japanese stiltgrass, black willow and sweet gum seedlings, various sedges, and dogbane.

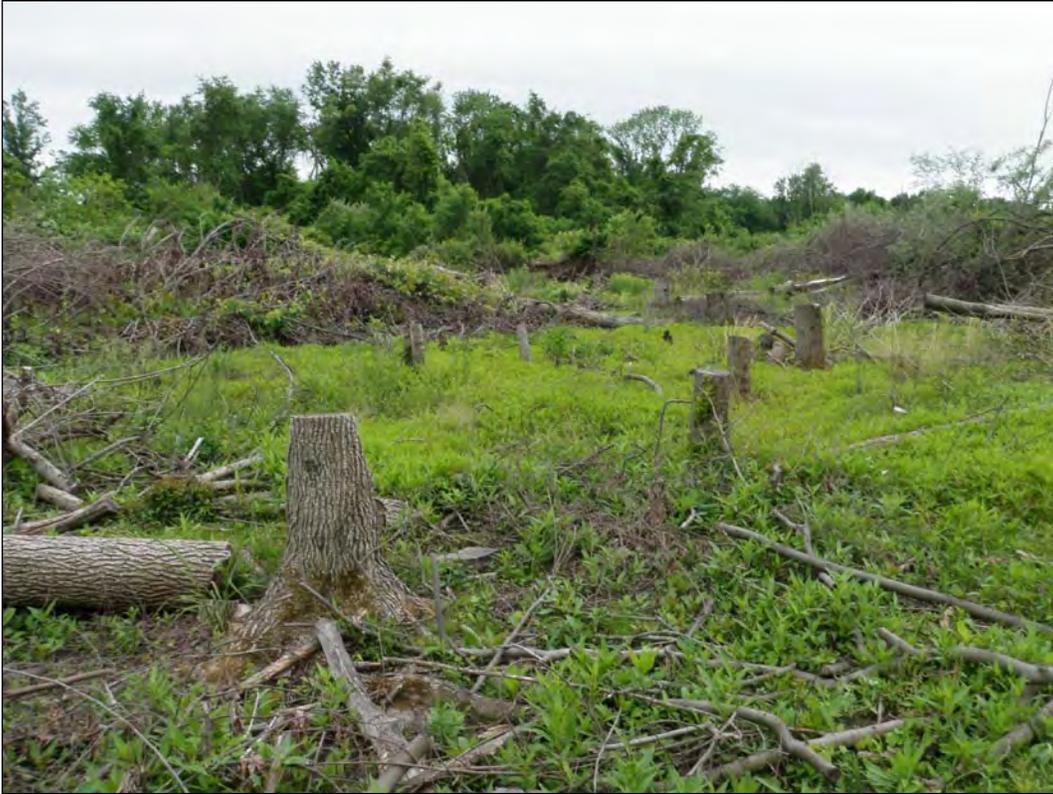
**Photo W** – View, facing east near EA2, showing an early successional upland field that was recently cleared as part of runway protection zone obstruction removal. The area was dominated by lady’s thumb with lesser amounts of field garlic, woodsorrel, goldenrod, white clover, path rush, and bedstraw.

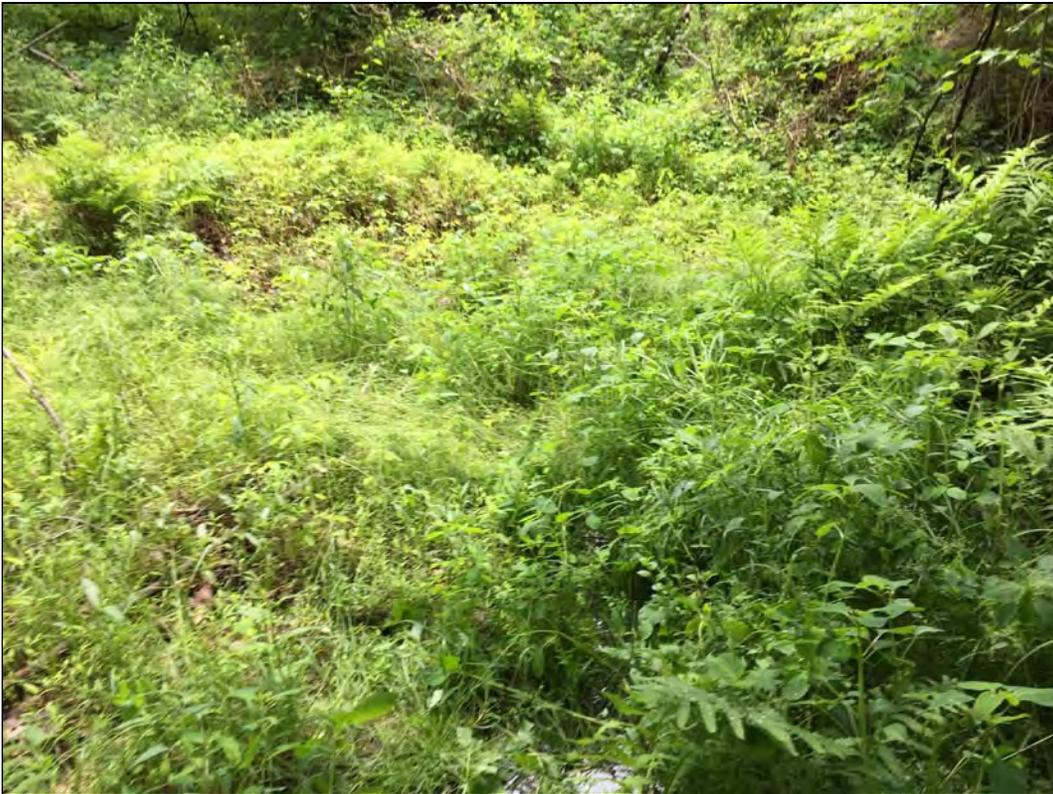
**Photo X** – View, facing northwest from Flag FA84, of an emergent wetland containing sensitive fern, *Glyceria*, jewelweed, lurid sedge, and arrow-leaved tearthumb. Wetland FA is situated between Route 95 and Sam Weinroth Road.

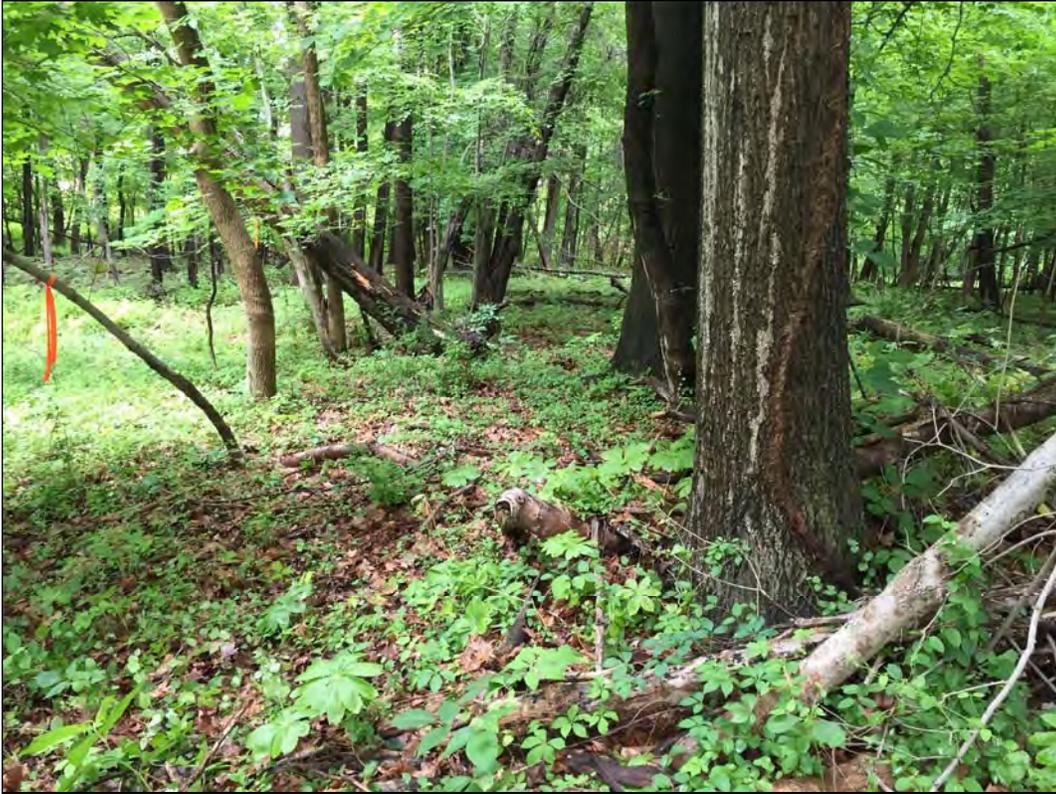
**Photo Y** – View, facing northwest near Flag FA84, of a secondary growth upland forest containing Northern red oak, red maple, sugar maple, fox grape, multiflora rose, Japanese stiltgrass, may apple, Virginia creeper, and garlic mustard.

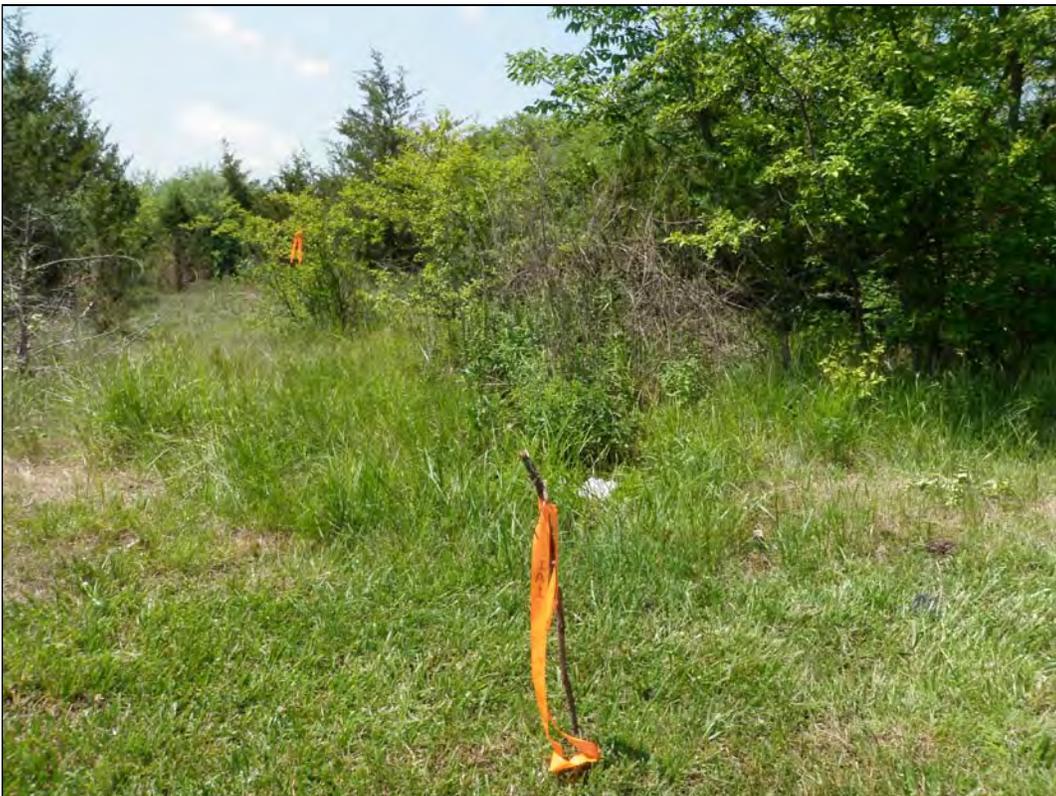
**Photo Z** – View, facing west at Flag IA1 (facing IA67), of an emergent/scrub-shrub wetland ditch located west of Sam Weinroth Road. Wetland IA was dominated by crab apple and green ash saplings, various sedges, purple loosestrife, beggarticks, and water purslane.

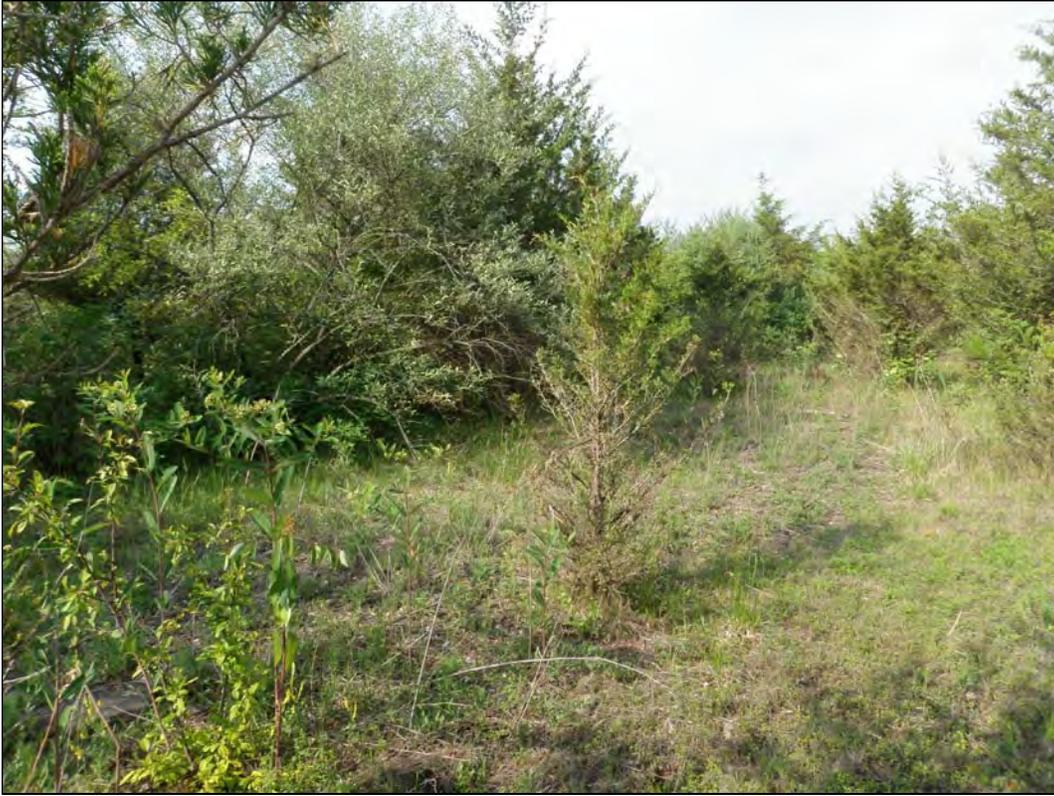
**Photo AA** – View, facing west near Flag IA67, of a late successional upland field dominated by Eastern red cedar saplings, various grasses, dogbane, wood sorrel, and common mugwort.

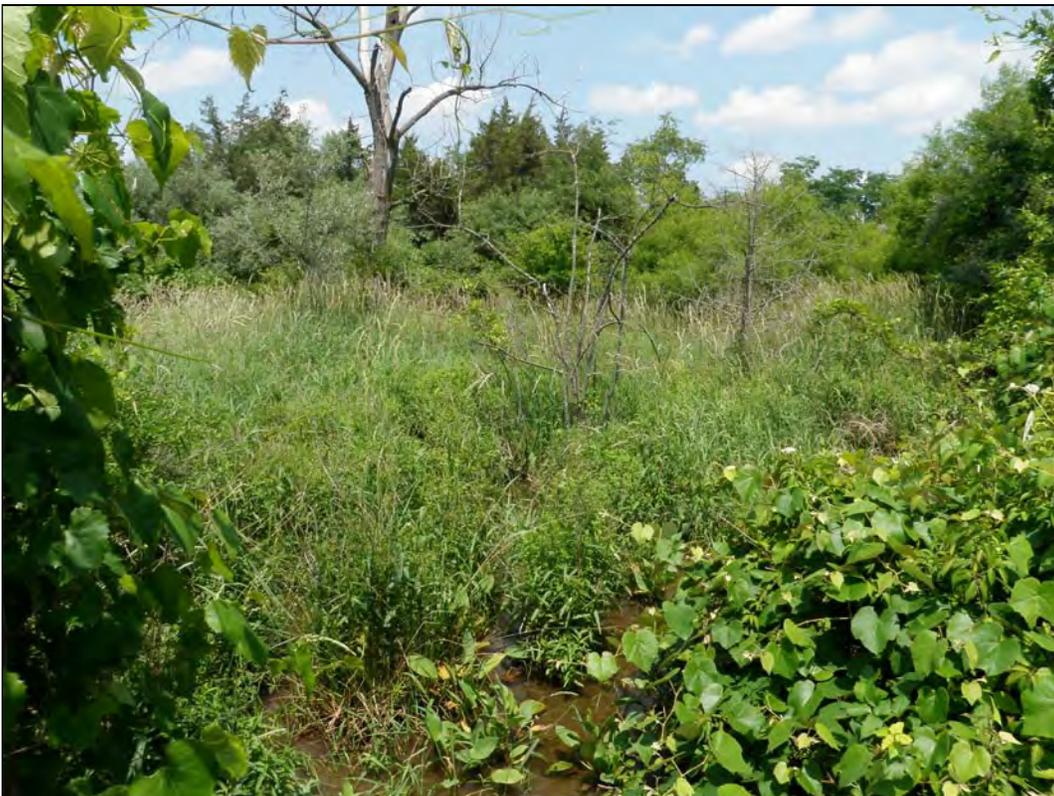
**Photo BB** – View, facing north at Flag JA3, of an isolated Palustrine emergent wetland located near the County maintenance yard. Wetland JA contained purple loosestrife, spatterdock, river bulrush, reed canary grass, spikerush, and bladder sedge.

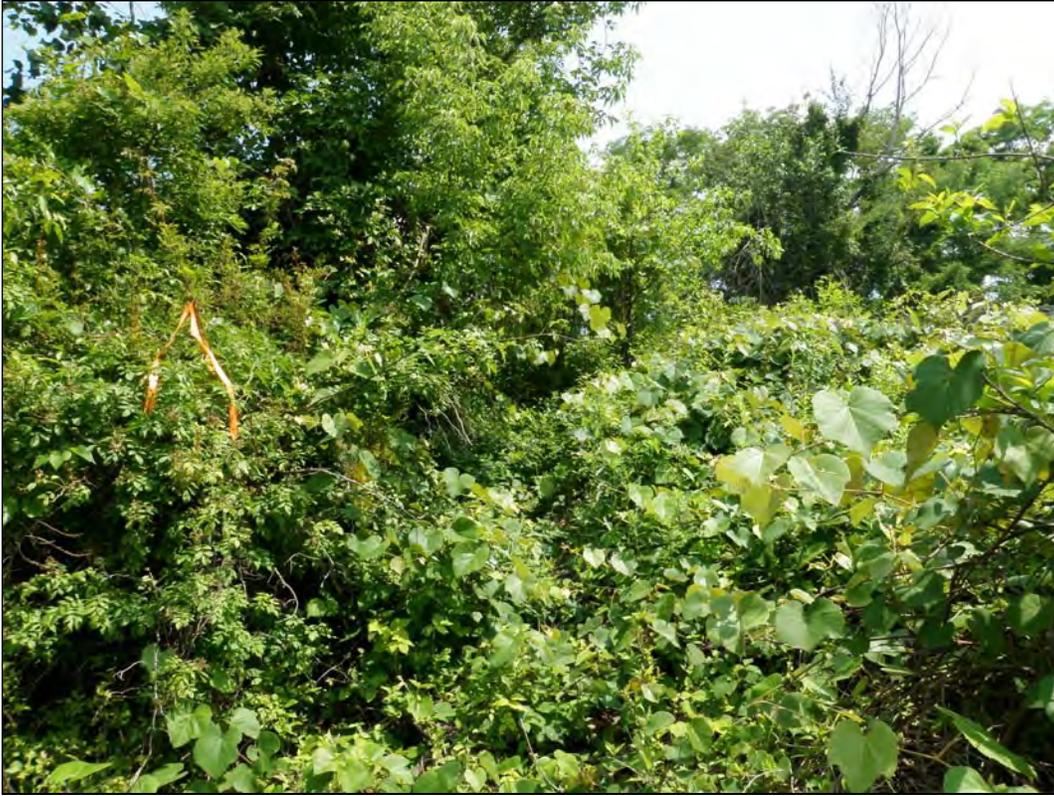
**Photo CC** – View, facing northeast at Flag JA3, of a woody old field containing Eastern cottonwood, crab apple and black cherry saplings, multiflora rose, grape, Japanese honeysuckle, Virginia creeper, common mugwort, and poison ivy.

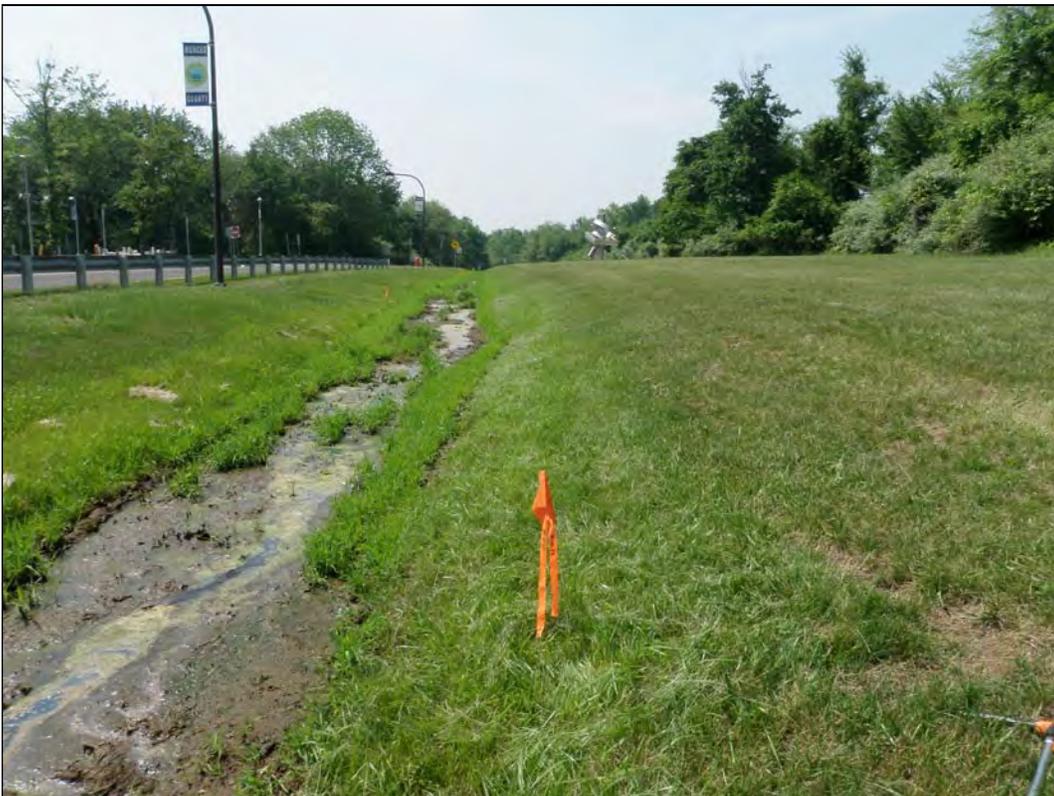
**Photo DD** – View, facing south toward Flag MA25, of a Palustrine emergent wetland ditch located parallel to Sam Weinroth Road, west of the Terminal Parking Lots. Wetland MA contained reed canary grass, watercress, and grasses. Maintained upland lawn (right) contained various grasses, white clover, Kentucky blue grass, crabgrass, English plantain, and common dandelion.

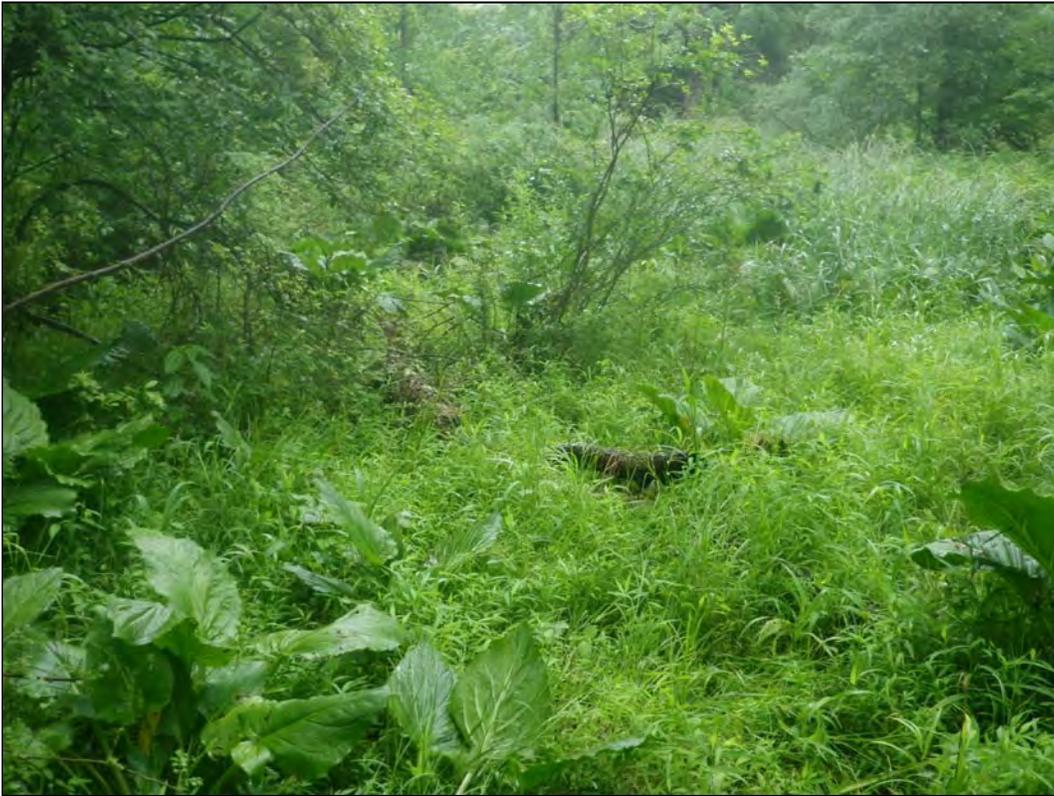
**Photo EE** – View, facing west near Flag PA148, of a Palustrine forested/emergent wetland complex associated with Ewing Creek and containing American elm, green ash, winterberry, multiflora rose, Japanese stiltgrass, skunk cabbage, reed canary grass, and arrow-leaved tearthumb.

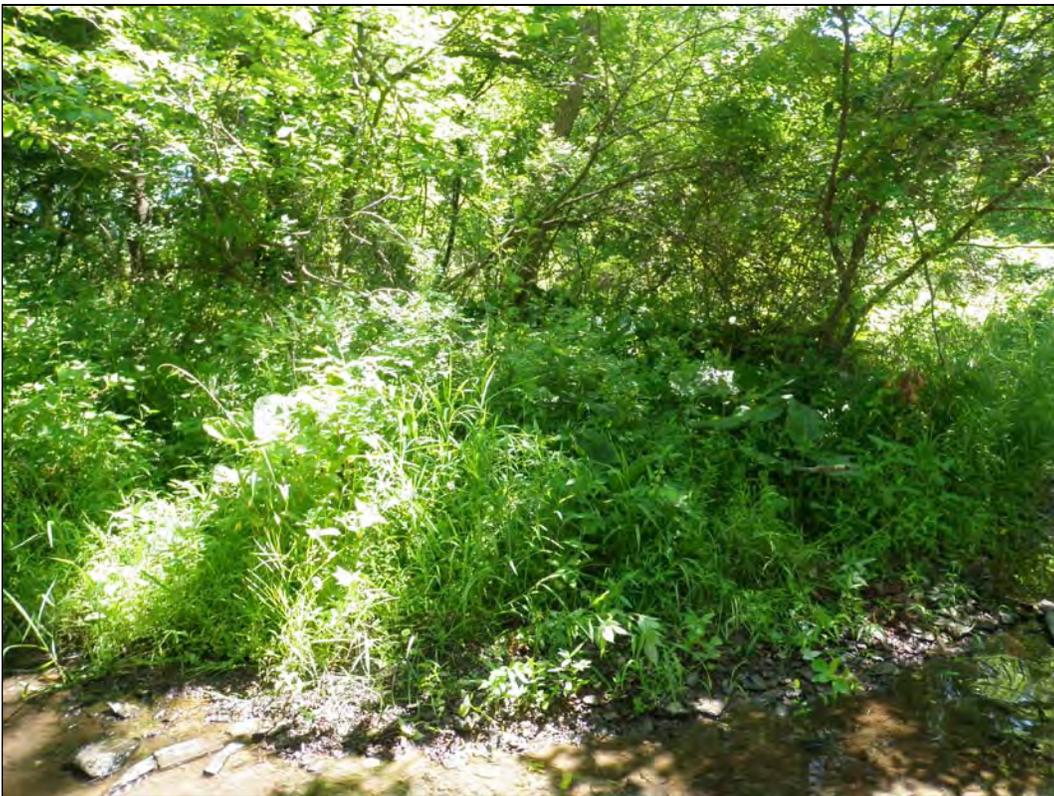
**Photo FF** – View, facing northeast near Flag PA179, of a Palustrine forested wetland associated with Ewing Creek, which contains black walnut, Northern spicebush, multiflora rose, skunk cabbage, rice cutgrass, clearweed, lady's thumb, and halberd-leaved tearthumb.

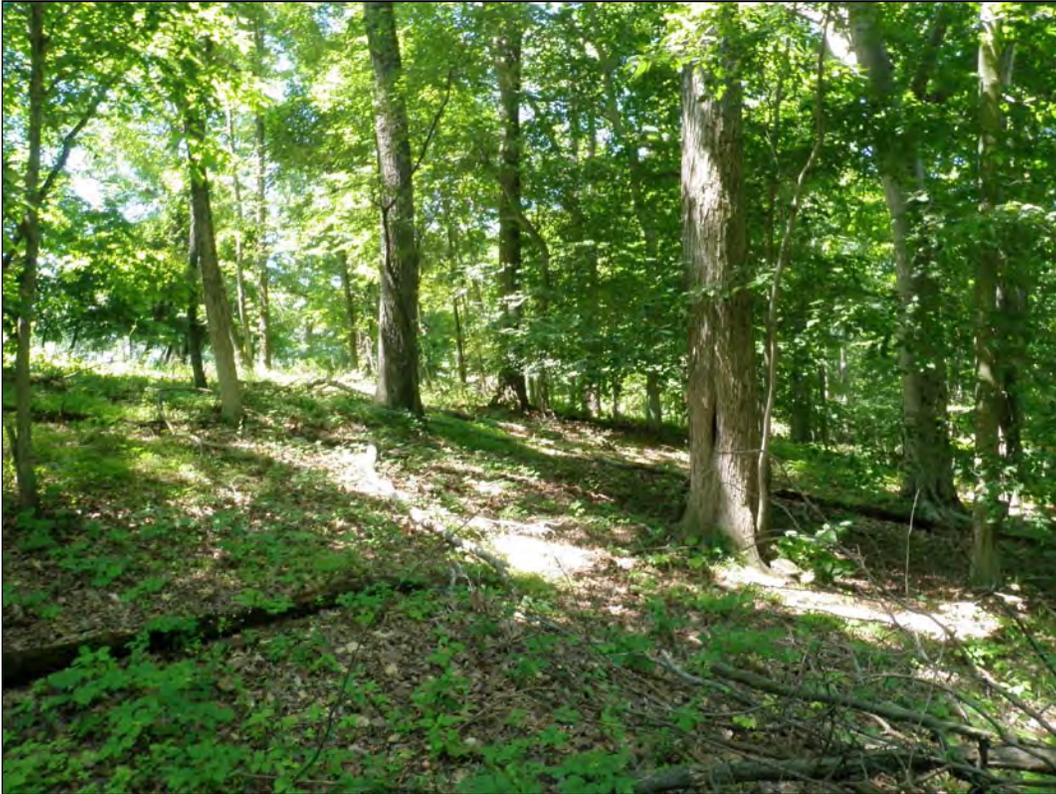
**Photo GG** – View, facing west-northwest from Flag PA179, of secondary growth upland forest containing red maple, ash, blue beech, shagbark hickory, sugar maple, Japanese honeysuckle, Virginia creeper, and poison ivy.

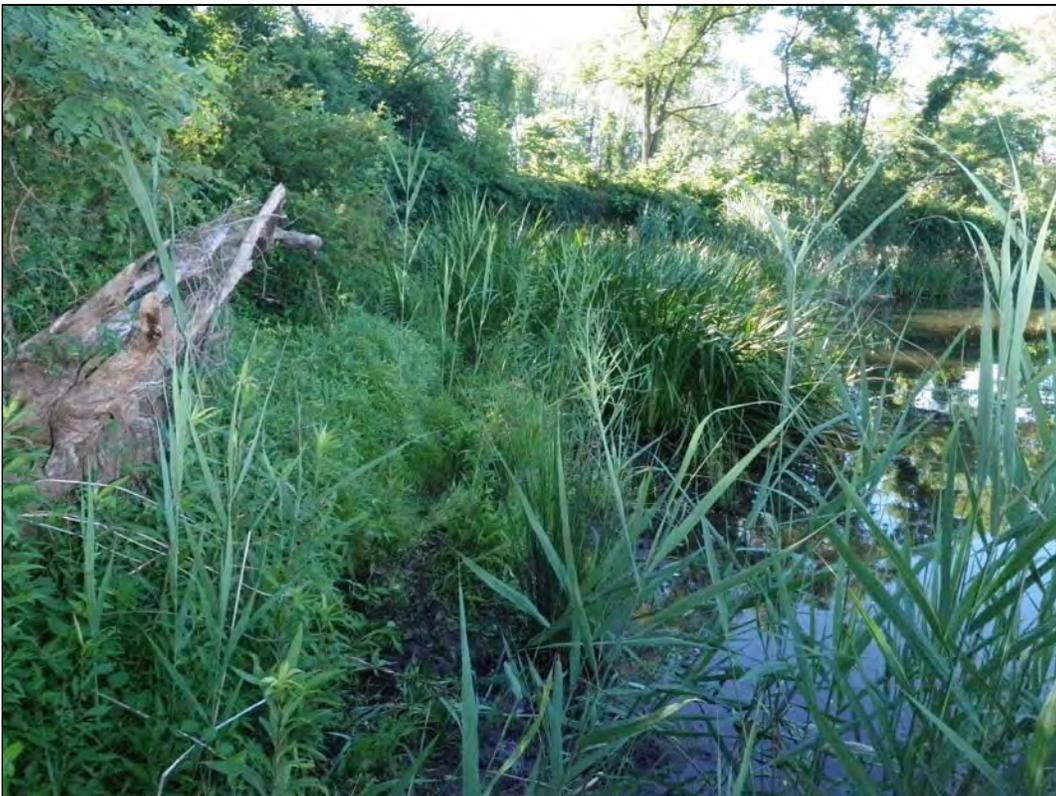
**Photo HH** – View, facing southeast at Flag RA96, of a Palustrine emergent wetland fringe located along a pond and containing New York ironweed, soft rush, common reed, sweetflag, beggarticks, and Japanese stiltgrass. Wetland RA is situated within the southern portion of Mountain View Golf Course, north of Route 95.

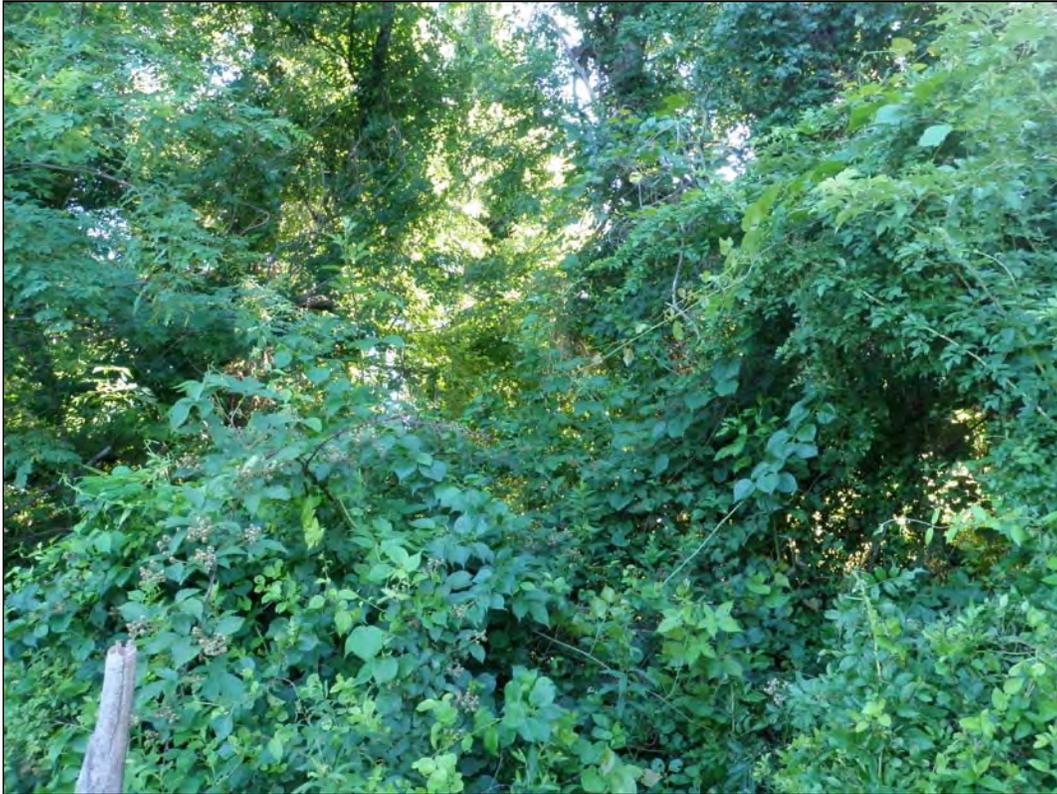
**Photo II** – View, facing east at Flag RA97, of secondary growth upland forest containing black locust, multiflora rose, oriental bittersweet, Japanese stiltgrass, Japanese honeysuckle, common mugwort, American pokeweed, and field garlic.

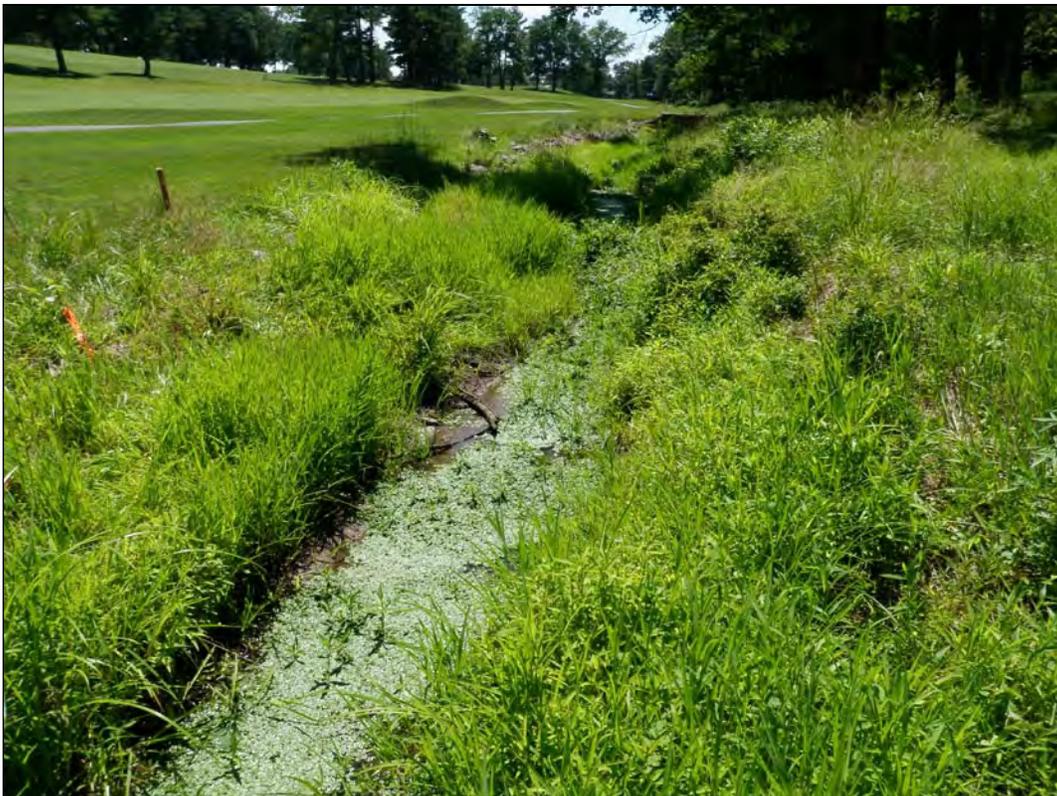
**Photo JJ** – View, facing west from Flag SA2, of a Palustrine emergent wetland ditch located along the northern perimeter of Mountain View Golf Course. Wetland SA was dominated by mild water pepper, duckweed, arrow-leaved tearthumb, rice cutgrass, and Japanese stiltgrass.

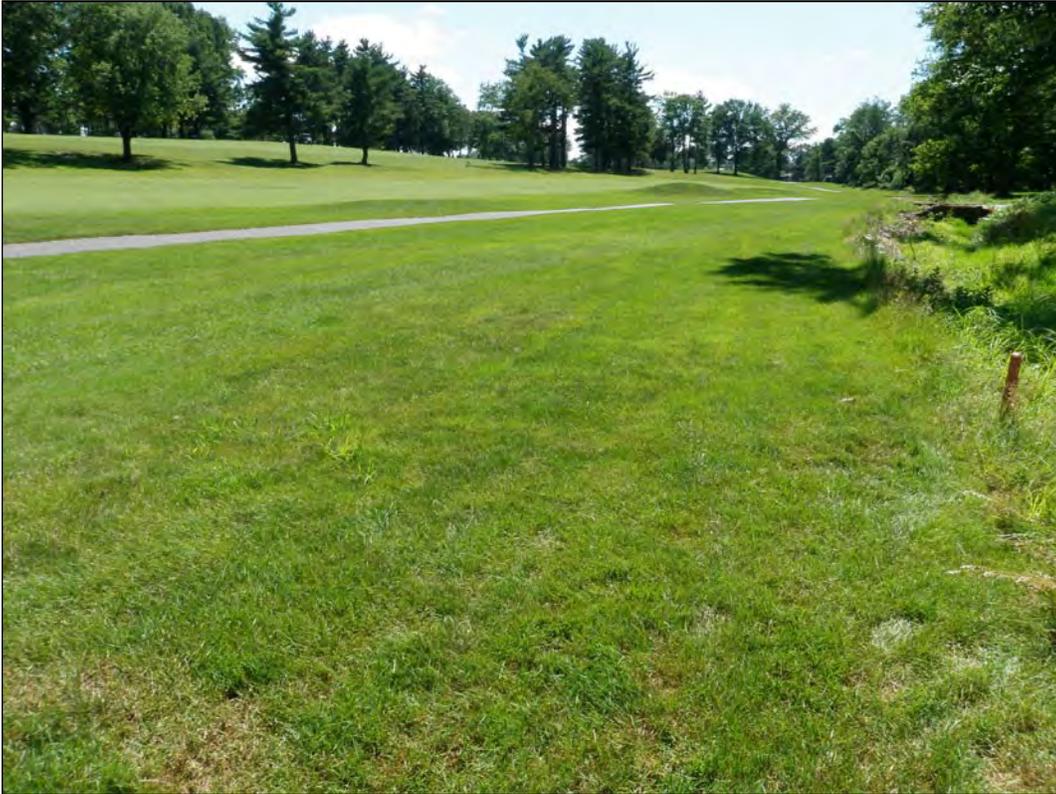
**Photo KK** – View, facing west near Flag SA2, of maintained turf associated with Mountain View Golf Course. Regularly and periodically maintained upland turf contained Kentucky bluegrass, fescue, and common mugwort.
